Emergency pipeline on a pontoon bridge

Emergency bypass on a pontoon bridge

A high-speed emergency task for Czajka treatment plant

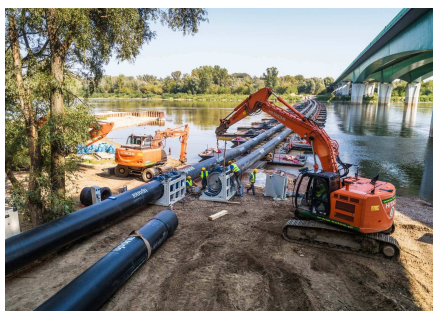
Emergency pipeline on a pontoon bridge

This time, the total length of two DN1,000mm emergency lines was 3,200 metres. Extending the pipeline by 900 metres in total made it possible to connect it directly to the Farysa treatment facility, enabling the pipeline to operate even if water levels increased on the Vistula River. The project used the same pipes as in 2019 with additional sections delivered as a matter of priority from Uponor's factory in Kleszczów. Before work began, Uponor conducted comprehensive lab tests – checking the pipes for surface scratches – as well as weld rupture strength tests. All pipes were found to be fully suited for reuse. As before, thanks to the determination and dedication of Uponor's personnel and service crews, the pipeline was fully operational within 13 days of the commission. Due to the excellent properties of the PE-HD technology, as well as failsafe installation by means of butt welding, the pipeline had the potential to operate for years. It functioned without issues and was only disassembled again when the pontoon bridge had to be removed due to risk of damage from ice sheets forming on the river in October 2020.

Usually, projects like these take months to complete but in this case speed was of the essence. In an amazing feat, Uponor Infra was able to deliver and join the pipes required for the emergency pipeline in only eight days. The total length of the two lines of the DN1,000mm pipes was 2,200 metres, with two 250-metre sections resting on a pontoon bridge built by the Polish Army. To meet this unique challenge, Uponor mobilised all its resources: the production schedule at the company's factory in Kleszczów was adjusted to meet the urgent demand for pipes, with around-the-clock deliveries to the installation site, six service teams were delegated to the project and extra welding machines were brought in from other building sites from all over Poland. Thanks to the expertise, experience and tireless work of the Uponor crew, the new pipeline took over the functionality of the damaged collector after just 12 days, stopping the discharge of sewage into the Vistula River.
