Quick installation in the Konotopa channel

Weholite pipes PEHD SN4 DN2000 mm - 165 m

Weholite guaranteed a simple and quick installation in the Konotopa channel

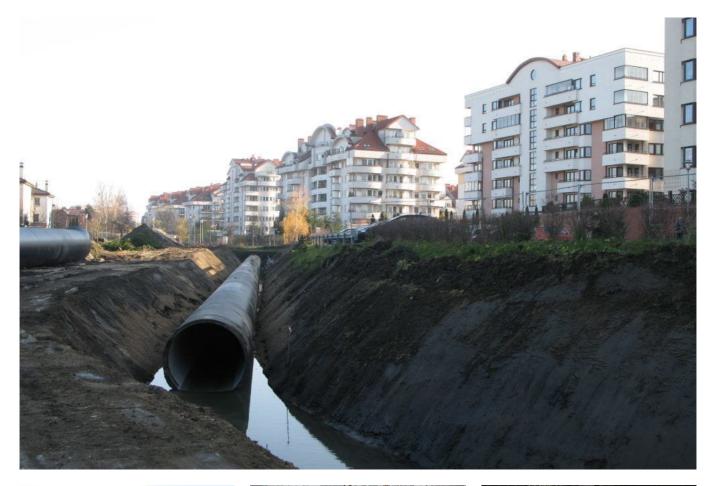
Weholite guaranteed a simple and quick installation in the Konotopa channel

Following a tender, in September 2016 Drainage Construction Company Tolos was appointed as the general contractor for the project. Uponor Infra delivered a total of 165 metres of structured-wall PE-HD Weholite, DN/ID 2,000mm SN4 pipes to the installation site. Prep work included clearing the channel of concrete slab lining, dredging the ditch to make room for the new pipeline and laying the bedding. Uponor Infra pipe service staff then joined up the Weholite pipes to form two sections. The work was carried out on dry land on the right bank of the channel, by means of automatic extrusion welding using a WLI-3000 machine. This guaranteed the 100% tightness and homogeneity of the pipeline. A 100- metre section of pipeline was then lowered into the ditch, followed by the remaining 50-metre section with a fitted bend two days later. Since the channel was operational during installation, the two connecting sections of the pipeline were raised above the water level, where they were welded together. The pipeline was then connected to a reinforced concrete inlet of the underground section of the channel. A socket- and- spigot DN/ID200mm joint was fitted onto the pipeline, connecting it to an existing stormwater channel. Finally, the ditch was backfilled. At the spot where the new pipeline meets the open section of the channel, an outlet was secured with a steel grate to prevent unauthorised entry. The installation was completed in December 2016.
