Reference

Emergency pipeline on a pontoon bridge

Emergency bypass on a pontoon bridge

A high-speed emergency task for Czajka treatment plant

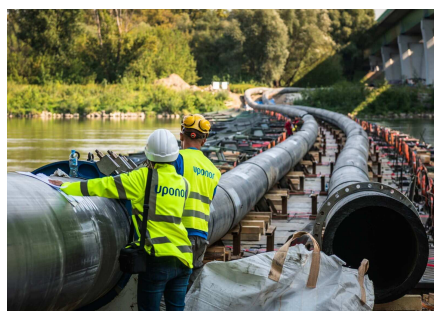
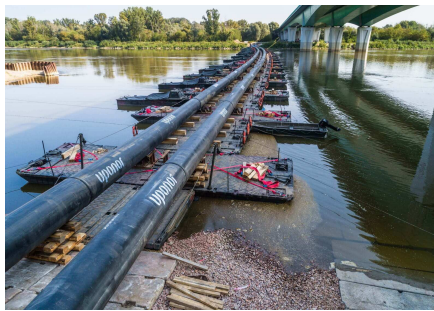
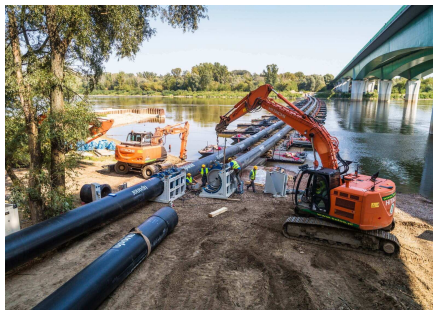
Emergency pipeline on a pontoon bridge

This time, the total length of two DN1,000mm emergency lines was 3,200 metres. Extending the pipeline by 900 metres in total made it possible to connect it directly to the Farysa treatment facility, enabling the pipeline to operate even if water levels increased on the Vistula River. The project used the same pipes as in 2019 with additional sections delivered as a matter of priority from Uponor's factory in Kleszczów. Before work began, Uponor conducted comprehensive lab tests – checking the pipes for surface scratches – as well as weld rupture strength tests. All pipes were found to be fully suited for reuse. As before, thanks to the determination and dedication of Uponor's personnel and service crews, the pipeline was fully operational within 13 days of the commission. Due to the excellent properties of the PE-HD technology, as well as failsafe installation by means of butt welding, the pipeline had the potential to operate for years. It functioned without issues and was only disassembled again when the pontoon bridge had to be removed due to risk of damage from ice sheets forming on the river in October 2020.
