## Drinking water passing through contaminated area in Thisted

Citizens' safety comes first when water utility sought to protect the municipality's drinking water from toxic chemicals.

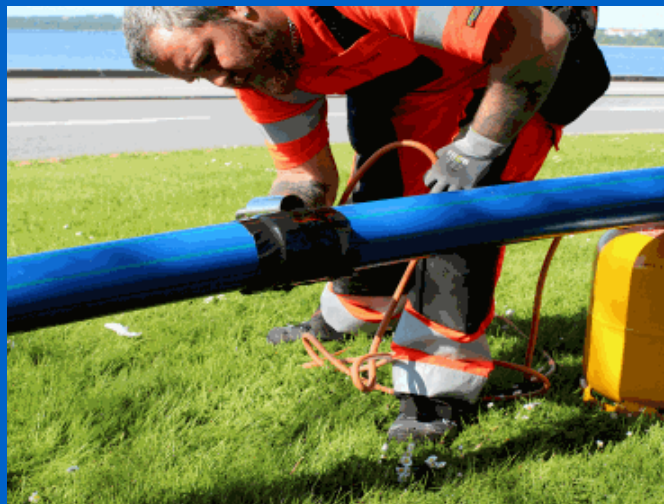
Citizens' safety was key when a Danish water utility sought to protect the municipality's drinking water from toxic chemicals at a former industrial site with busy traffic. By choosing Uponor Barrier PLUS pipes, the utility company now has a fully plastic barrier pipe system with an expected lifespan of more than 100 years.
