## Renovation of damaged stoneware collector – cracking/short relining

## Renovation of damaged stoneware collector – cracking/short relining with the use of VipLiner modules

Tomaszów Mazowiecki, Poland

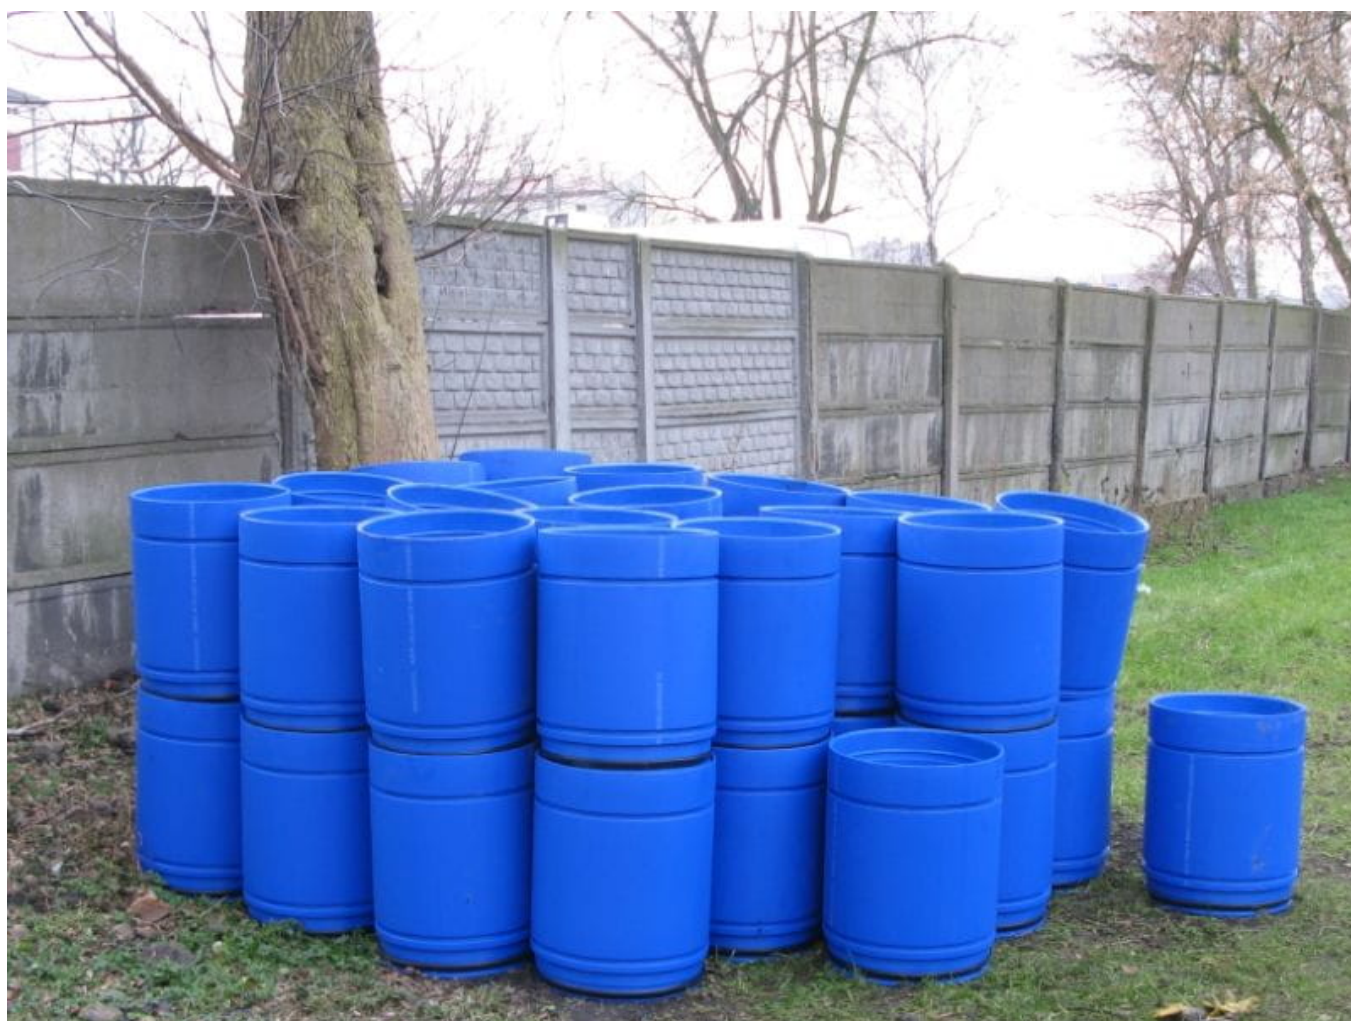
**Renovation of damaged stoneware collector – cracking/short relining with the use of VipLiner modules**

In Tomaszów Mazowiecki renovation of a damaged stoneware collector was carried out by means of static cracking method using VipLiner polyethylene modules. In 2013 a decision was made to carry out renovation of the stoneware collector of diameter dn250mm and dn400mm. The collector was leaking in numerous places, particularly in the places of its connection with the manholes.

Upon analysing various renovation technologies it was resolved to repair the collector with the use of VipLiner polyethylene modules PE100 RC with increased resistance to propagation of cracks, point pressure and result of scratching, Blejkan, the contractor of the project, applied the static cracking method, which concerned the crushing of the old collector with the use of the head connected by steel bolted poles with the hydraulic drive hoist and parallel insertion of VipLiner modules after the head. This method allowed to improve the hydraulic parameters of the sewage network. Uponor Infra delivered for this investment VipLiner modules of 0.5 m length and diameter respectively higher than the renovated section (dn355 and 450mm).

The works were carried out in winter at the turn of 2013/2014. The renovation included 8 sections and the longest section between the manholes was 60 m. The contractor commended the easy and simple nature of installation of the modules and the speed of works using VipLiner modules (the average renovation time of a section was approx. 3 days).
