Renovation of damaged stoneware collector – cracking/short relining

Tomaszów Mazowiecki, Poland 2014

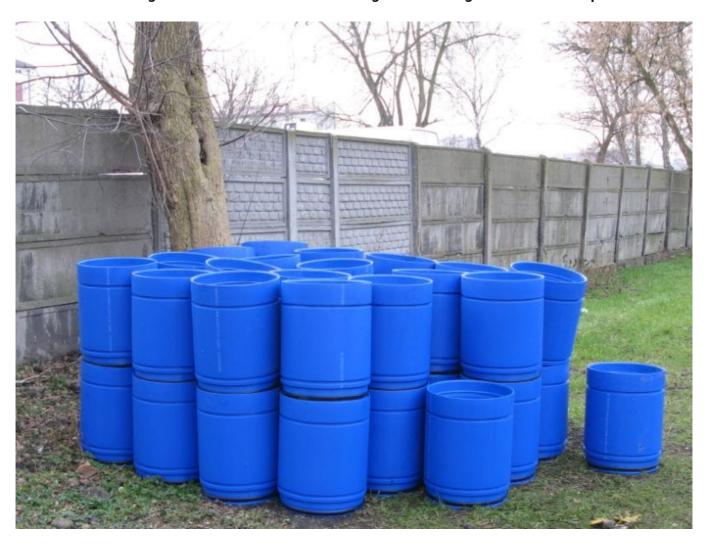
Renovation of damaged stoneware collector - cracking/short relining with the use of VipLiner modules

Upon analysing various renovation technologies it was resolved to repair the collector with the use of VipLiner polyethylene modules PE100 RC with increased resistance to propagation of cracks, point pressure and result of scratching, Blejkan, the contractor of the project, applied the static cracking method, which concerned the crushing of the old collector with the use of the head connected by steel bolted poles with the hydraulic drive hoist and parallel insertion of VipLiner modules after the head. This method allowed to improve the hydraulic parameters of the sewage network. Uponor Infra delivered for this investment VipLiner modules of 0.5 m length and diameter respectively higher than the renovated section (dn355 and 450mm).

The works were carried out in winter at the turn of 2013/2014. The renovation included 8 sections and the longest section between the manholes was 60 m. The contractor commended the easy and simple nature of installation of the modules and the speed of works using VipLiner modules (the average renovation time of a section was approx. 3 days).
