### Renovation of damaged stoneware collector – cracking/short relining

### Renovation of damaged stoneware collector – cracking/short relining with the use of VipLiner modules

In Tomaszów Mazowiecki renovation of a damaged stoneware collector was carried out by means of static cracking method using VipLiner polyethylene modules

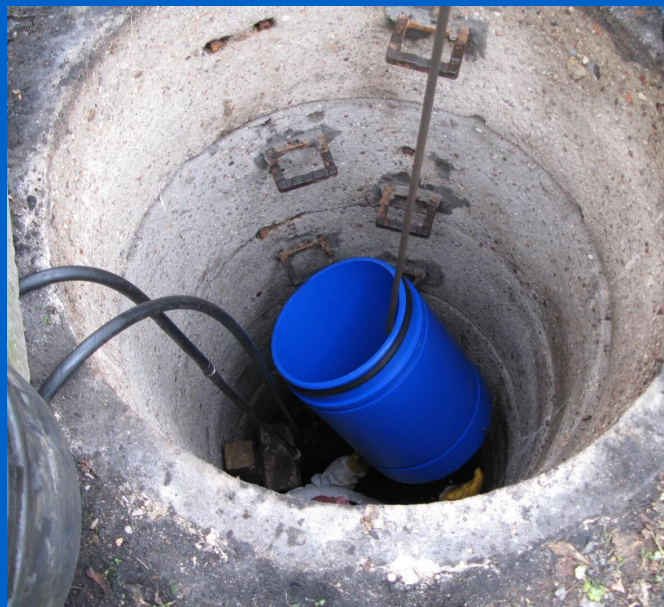
In Tomaszów Mazowiecki renovation of a damaged stoneware collector was carried out by means of static cracking method using VipLiner polyethylene modules. In 2013 a decision was made to carry out renovation of the stoneware collector of diameter dn250mm and dn400mm. The collector was leaking in numerous places, particularly in the places of its connection with the manholes.

Upon analysing various renovation technologies it was resolved to repair the collector with the use of VipLiner polyethylene modules PE100 RC with increased resistance to propagation of cracks, point pressure and result of scratching, Blejkan, the contractor of the project, applied the static cracking method, which concerned the crushing of the old collector with the use of the head connected by steel bolted poles with the hydraulic drive hoist and parallel insertion of VipLiner modules after the head. This method allowed to improve the hydraulic parameters of the sewage network. Uponor Infra delivered for this investment VipLiner modules of 0.5 m length and diameter respectively higher than the renovated section (dn355 and 450mm).

The works were carried out in winter at the turn of 2013/2014. The renovation included 8 sections and the longest section between the manholes was 60 m. The contractor commended the easy and simple nature of installation of the modules and the speed of works using VipLiner modules (the average renovation time of a section was approx. 3 days).
