Renovation of damaged stoneware collector – cracking/short relining

Renovation of damaged stoneware collector – cracking/short relining with the use of VipLiner modules

Location	Completion
Tomaszów Mazowiecki, Poland	2014
Building Type	Product systems
Municipal	Renovation, Sewer Municipal
Project Type	
Renovation

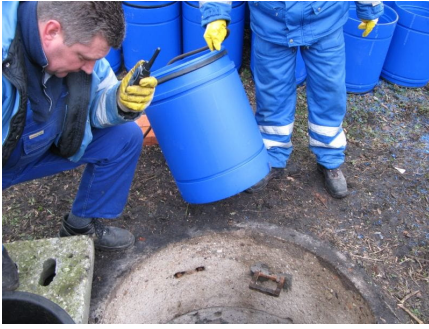
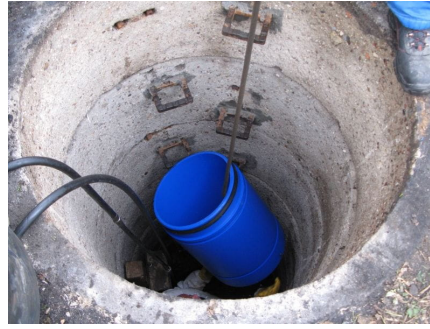
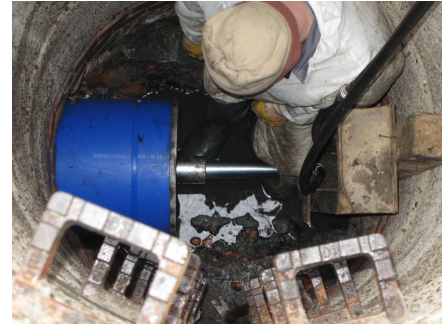
Renovation of damaged stoneware collector – cracking/short relining with the use of VipLiner modules

In Tomaszów Mazowiecki renovation of a damaged stoneware collector was carried out by means of static cracking method using VipLiner polyethylene modules. In 2013 a decision was made to carry out renovation of the stoneware collector of diameter dn250mm and dn400mm. The collector was leaking in numerous places, particularly in the places of its connection with the manholes.

Upon analysing various renovation technologies it was resolved to repair the collector with the use of VipLiner polyethylene modules PE100 RC with increased resistance to propagation of cracks, point pressure and result of scratching, Blejkan, the contractor of the project, applied the static cracking method, which concerned the crushing of the old collector with the use of the head connected by steel bolted poles with the hydraulic drive hoist and parallel insertion of VipLiner modules after the head. This method allowed to improve the hydraulic parameters of the sewage network. Uponor Infra delivered for this investment VipLiner modules of 0.5 m length and diameter respectively higher than the renovated section (dn355 and 450mm).

The works were carried out in winter at the turn of 2013/2014. The renovation included 8 sections and the longest section between the manholes was 60 m. The contractor commended the easy and simple nature of installation of the modules and the speed of works using VipLiner modules (the average renovation time of a section was approx. 3 days).
