# In place in a couple of days

Weholite pipes made of polypropylene met – and even surpassed – strict requirements in the renovation of a waste water channel at the Stora Enso Oulu mill in Northern Finland. Timed for a maintenance stop of nine days, the installation proceeded quickly and was finished well before the deadline.

## Project Facts:

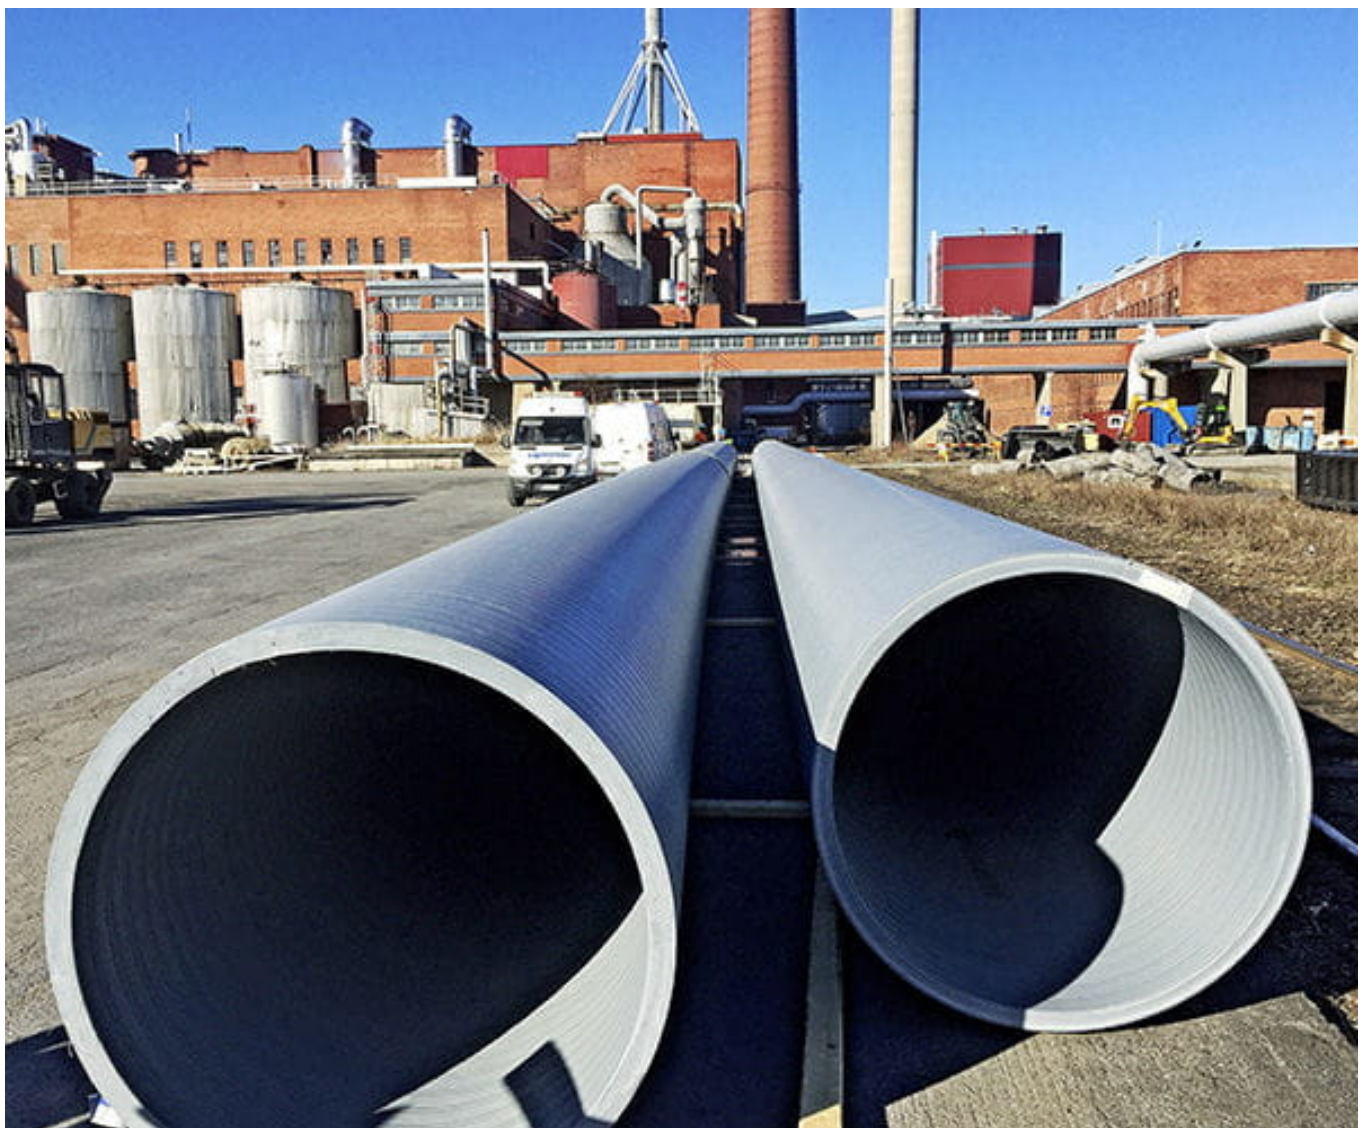
### **In place in a couple of days**

Uponor Infra began the preparatory work the week before the renovation. The Weholite pipes, which had an interior diameter of 1,200 millimetres, were delivered to the worksite in 21 metre-long sections.

“During the first week, we prepared connections and welded two pipes together, so that the first 42-metre long pipe going under the building would be ready at the beginning of the maintenance stop,” says Foreman Veli-Matti Hakala from Uponor Infra.

“When the pipe fed under the building was in place, an excavator was used to insert the other 42-metre long pipe into the channel outside the building.”
