## Renovation of damaged stoneware collector – cracking/short relining

## Renovation of damaged stoneware collector – cracking/short relining with the use of VipLiner modules

| Tomaszów Mazowiecki, Poland | 2014 |

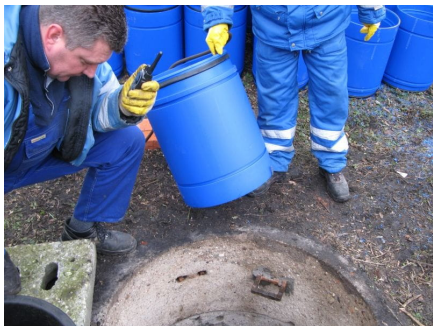
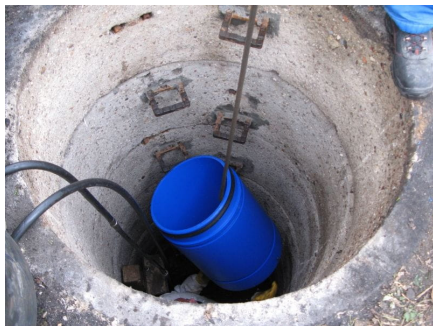
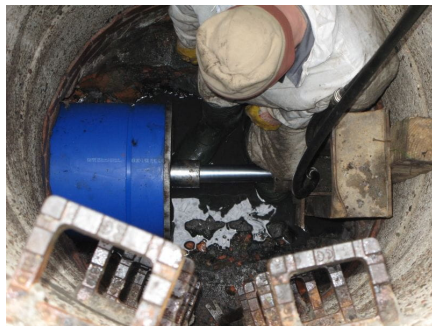
### Renovation of damaged stoneware collector – cracking/short relining with the use of VipLiner modules

In Tomaszów Mazowiecki renovation of a damaged stoneware collector was carried out by means of static cracking method using VipLiner polyethylene modules. In 2013 a decision was made to carry out renovation of the stoneware collector of diameter dn250mm and dn400mm. The collector was leaking in numerous places, particularly in the places of its connection with the manholes.

Upon analysing various renovation technologies it was resolved to repair the collector with the use of VipLiner polyethylene modules PE100 RC with increased resistance to propagation of cracks, point pressure and result of scratching, Blejkan, the contractor of the project, applied the static cracking method, which concerned the crushing of the old collector with the use of the head connected by steel bolted poles with the hydraulic drive hoist and parallel insertion of VipLiner modules after the head. This method allowed to improve the hydraulic parameters of the sewage network. Uponor Infra delivered for this investment VipLiner modules of 0.5 m length and diameter respectively higher than the renovated section (dn355 and 450mm).

The works were carried out in winter at the turn of 2013/2014. The renovation included 8 sections and the longest section between the manholes was 60 m. The contractor commended the easy and simple nature of installation of the modules and the speed of works using VipLiner modules (the average renovation time of a section was approx. 3 days).
