Renovation of damaged stoneware collector – cracking/short relining

Renovation of damaged stoneware collector – cracking/short relining with the use of VipLiner modules

In Tomaszów Mazowiecki renovation of a damaged stoneware collector was carried out by means of static cracking method using VipLiner polyethylene modules

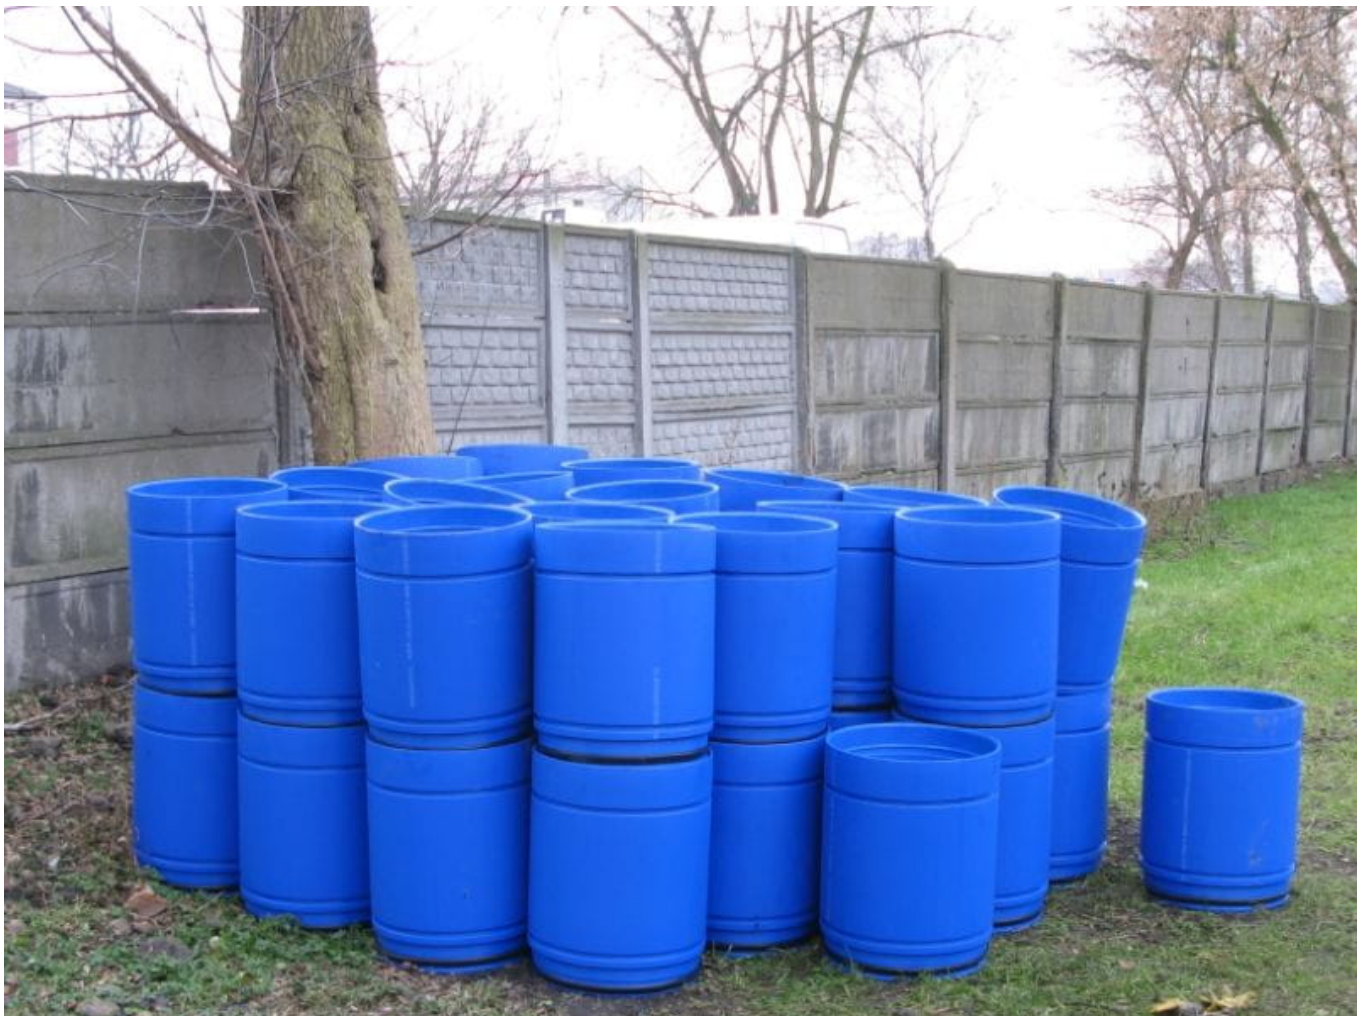
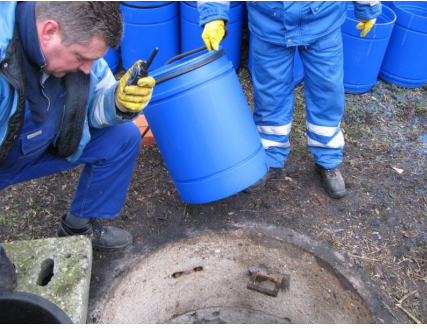
Renovation of damaged stoneware collector – cracking/short relining with the use of VipLiner modules

Upon analysing various renovation technologies it was resolved to repair the collector with the use of VipLiner polyethylene modules PE100 RC with increased resistance to propagation of cracks, point pressure and result of scratching, Blejkan, the contractor of the project, applied the static cracking method, which concerned the crushing of the old collector with the use of the head connected by steel bolted poles with the hydraulic drive hoist and parallel insertion of VipLiner modules after the head. This method allowed to improve the hydraulic parameters of the sewage network. Uponor Infra delivered for this investment VipLiner modules of 0.5 m length and diameter respectively higher than the renovated section (dn355 and 450mm).

The works were carried out in winter at the turn of 2013/2014. The renovation included 8 sections and the longest section between the manholes was 60 m. The contractor commended the easy and simple nature of installation of the modules and the speed of works using VipLiner modules (the average renovation time of a section was approx. 3 days).
