## Emergency pipeline on a pontoon bridge

## Emergency bypass on a pontoon bridge

## A high-speed emergency task for Czajka treatment plant

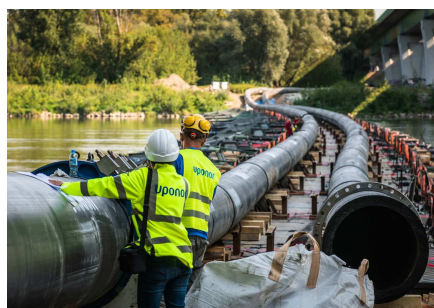
## Emergency pipeline on a pontoon bridge

This time, the total length of two DN1,000mm emergency lines was 3,200 metres. Extending the pipeline by 900 metres in total made it possible to connect it directly to the Farysa treatment facility, enabling the pipeline to operate even if water levels increased on the Vistula River. The project used the same pipes as in 2019 with additional sections delivered as a matter of priority from Uponor's factory in Kleszczów. Before work began, Uponor conducted comprehensive lab tests – checking the pipes for surface scratches – as well as weld rupture strength tests. All pipes were found to be fully suited for reuse. As before, thanks to the determination and dedication of Uponor's personnel and service crews, the pipeline was fully operational within 13 days of the commission. Due to the excellent properties of the PE-HD technology, as well as failsafe installation by means of butt welding, the pipeline had the potential to operate for years. It functioned without issues and was only disassembled again when the pontoon bridge had to be removed due to risk of damage from ice sheets forming on the river in October 2020.
