Renovation of damaged stoneware collector – cracking/short relining

Renovation of damaged stoneware collector – cracking/short relining with the use of VipLiner modules

Location	Valmimisaeg
Tomaszów Mazowiecki, Poland	2014
Hoone tüüp	Product systems
Municipal	Renoveerimine, Sewer Municipal
Projekti tüüp	
Renovation

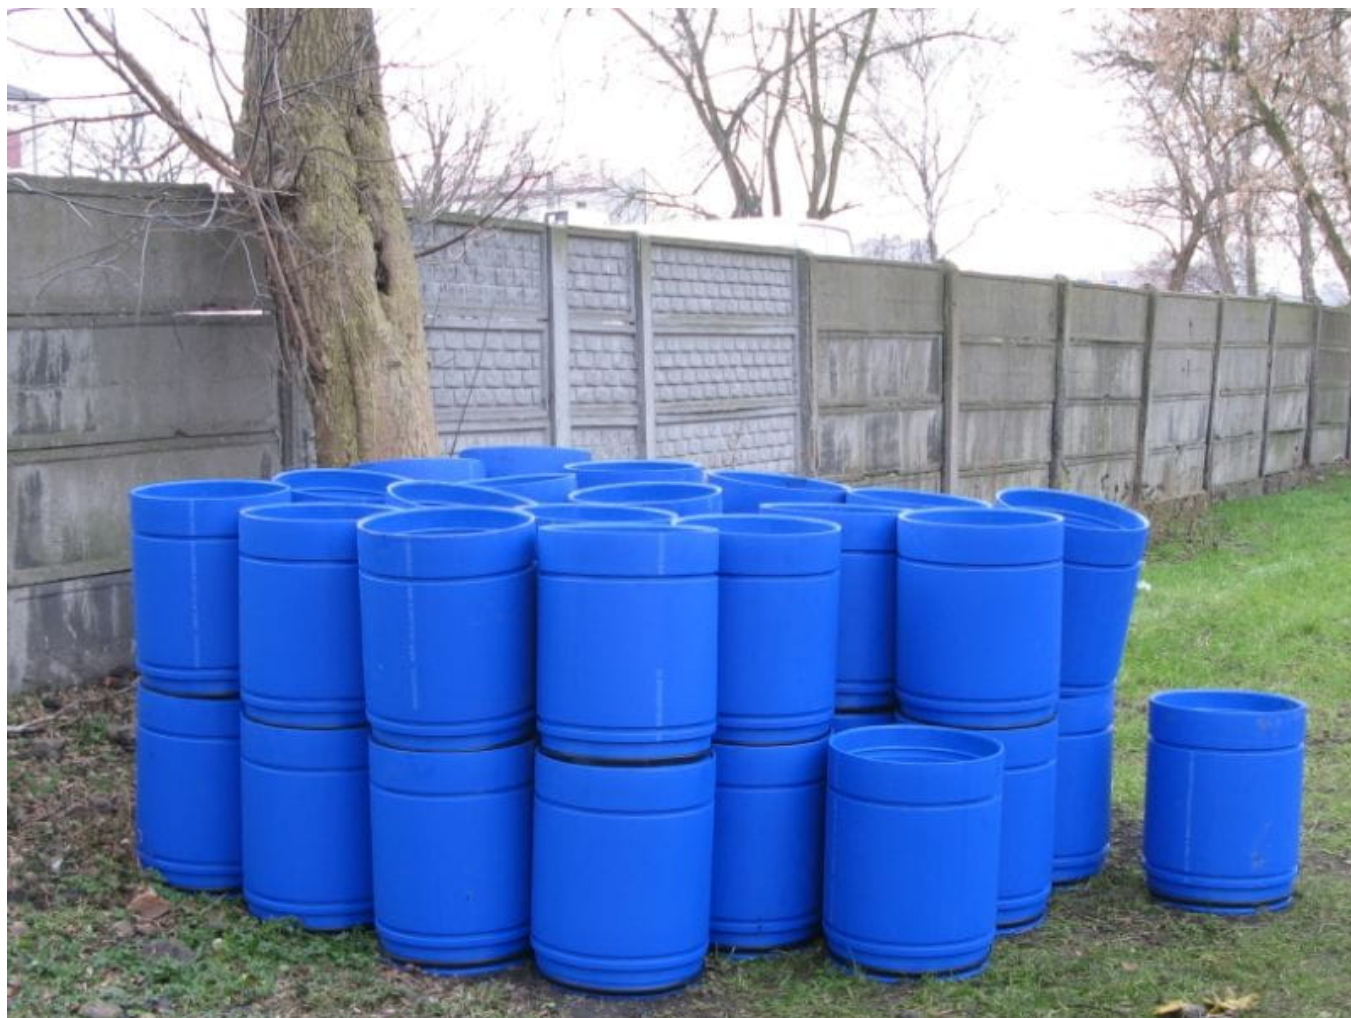
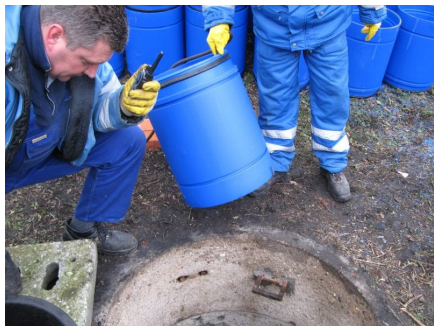
Renovation of damaged stoneware collector – cracking/short relining with the use of VipLiner modules

In Tomaszów Mazowiecki renovation of a damaged stoneware collector was carried out by means of static cracking method using VipLiner polyethylene modules

In Tomaszów Mazowiecki renovation of a damaged stoneware collector was carried out by means of static cracking method using VipLiner polyethylene modules. In 2013 a decision was made to carry out renovation of the stoneware collector of diameter dn250mm and dn400mm. The collector was leaking in numerous places, particularly in the places of its connection with the manholes.

Upon analysing various renovation technologies it was resolved to repair the collector with the use of VipLiner polyethylene modules PE100 RC with increased resistance to propagation of cracks, point pressure and result of scratching, Blejkan, the contractor of the project, applied the static cracking method, which concerned the crushing of the old collector with the use of the head connected by steel bolted poles with the hydraulic drive hoist and parallel insertion of VipLiner modules after the head. This method allowed to improve the hydraulic parameters of the sewage network. Uponor Infra delivered for this investment VipLiner modules of 0.5 m length and diameter respectively higher than the renovated section (dn355 and 450mm).

The works were carried out in winter at the turn of 2013/2014. The renovation included 8 sections and the longest section between the manholes was 60 m. The contractor commended the easy and simple nature of installation of the modules and the speed of works using VipLiner modules (the average renovation time of a section was approx. 3 days).
