Renovation of damaged stoneware collector – cracking/short relining

Renovation of damaged stoneware collector – cracking/short relining with the use of VipLiner modules

Location	Valmimisaeg
Tomaszów Mazowiecki, Poland	2014
Hoone tüüp	Product systems
Municipal	Renoveerimine, Sewer Municipal
Projekti tüüp	
Renovation

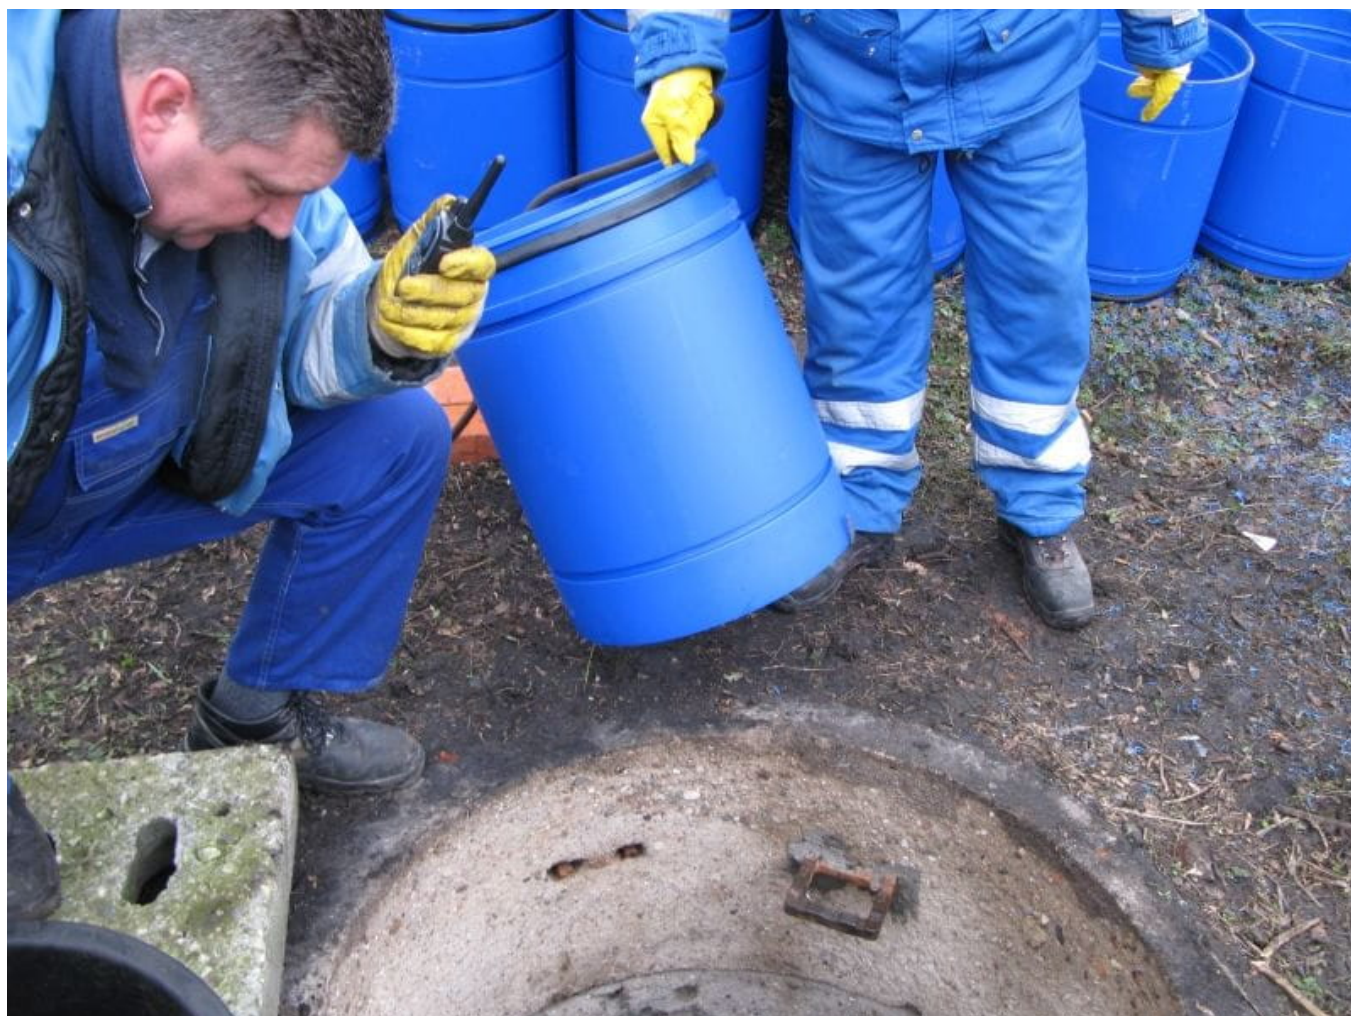
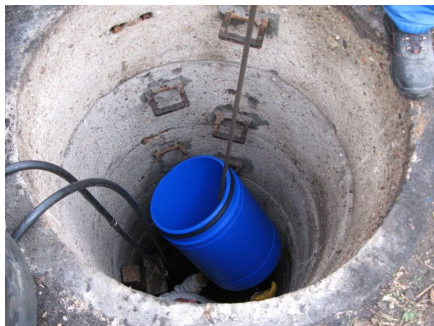
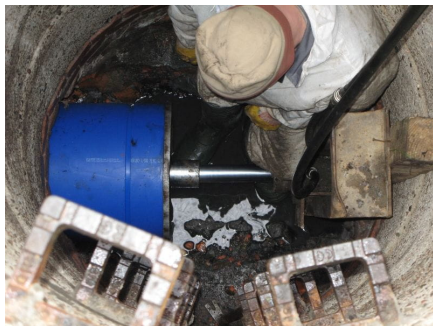
Renovation of damaged stoneware collector – cracking/short relining with the use of VipLiner modules

In Tomaszów Mazowiecki renovation of a damaged stoneware collector was carried out by means of static cracking method using VipLiner polyethylene modules. In 2013 a decision was made to carry out renovation of the stoneware collector of diameter dn250mm and dn400mm. The collector was leaking in numerous places, particularly in the places of its connection with the manholes.

Upon analysing various renovation technologies it was resolved to repair the collector with the use of VipLiner polyethylene modules PE100 RC with increased resistance to propagation of cracks, point pressure and result of scratching, Blejkan, the contractor of the project, applied the static cracking method, which concerned the crushing of the old collector with the use of the head connected by steel bolted poles with the hydraulic drive hoist and parallel insertion of VipLiner modules after the head. This method allowed to improve the hydraulic parameters of the sewage network. Uponor Infra delivered for this investment VipLiner modules of 0.5 m length and diameter respectively higher than the renovated section (dn355 and 450mm).

The works were carried out in winter at the turn of 2013/2014. The renovation included 8 sections and the longest section between the manholes was 60 m. The contractor commended the easy and simple nature of installation of the modules and the speed of works using VipLiner modules (the average renovation time of a section was approx. 3 days).
