Emergency pipeline on a pontoon bridge

Emergency bypass on a pontoon bridge

A high-speed emergency task for Czajka treatment plant

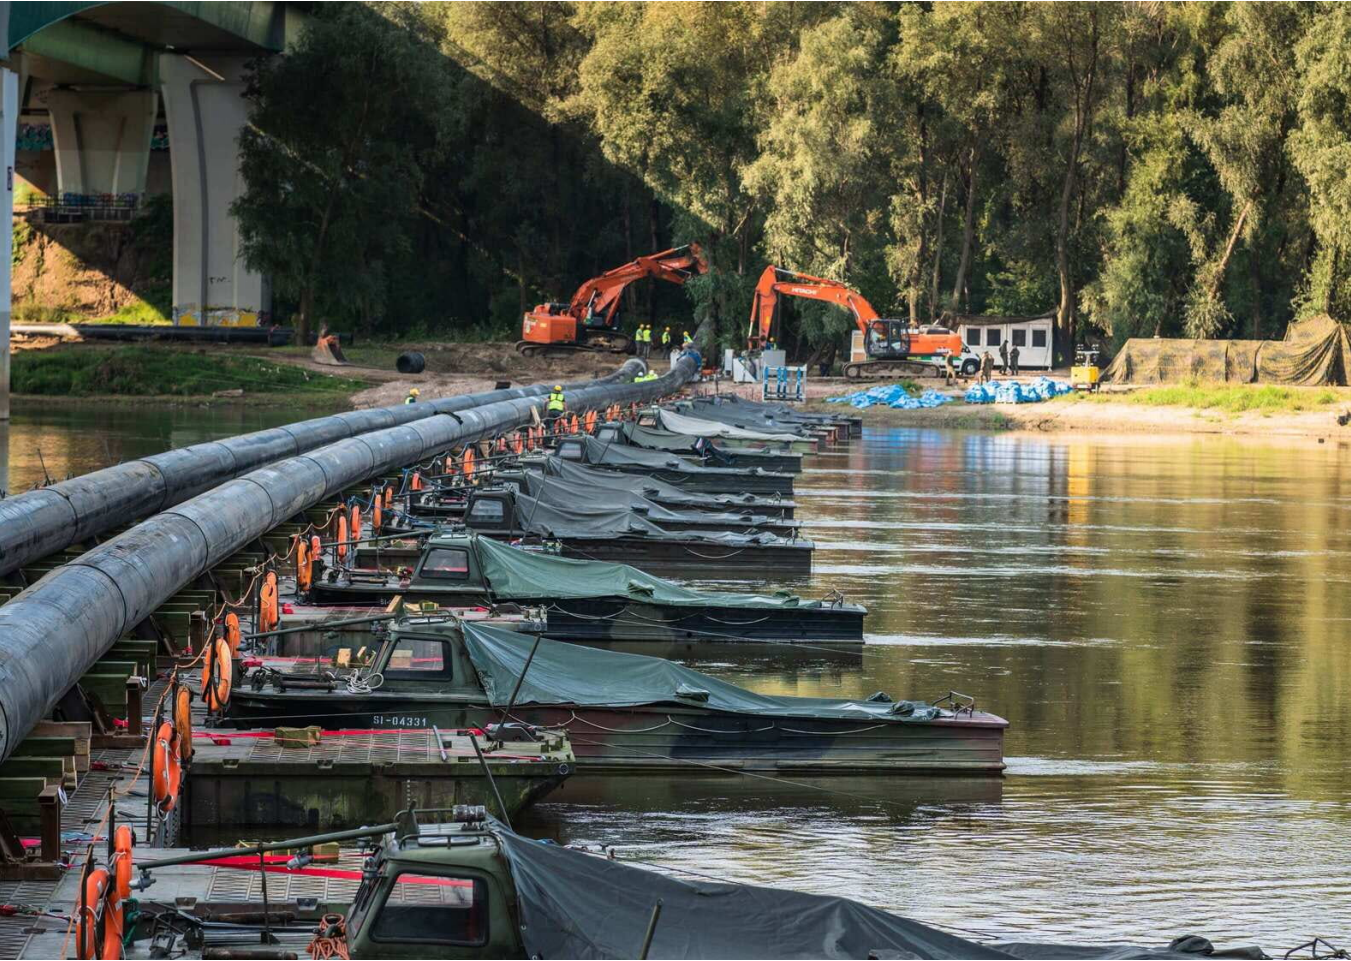
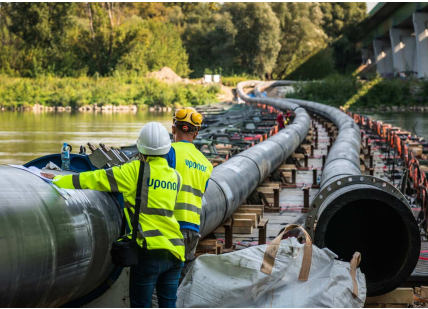
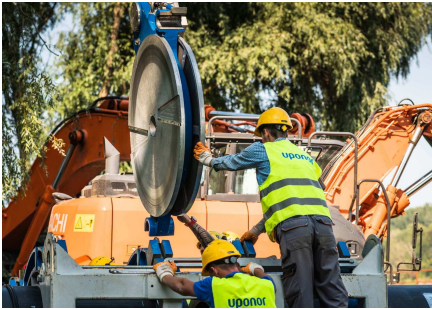
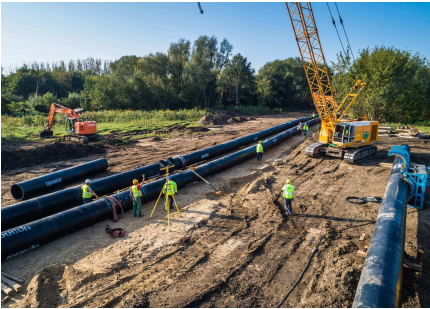
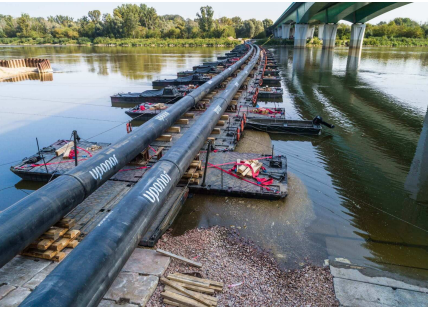
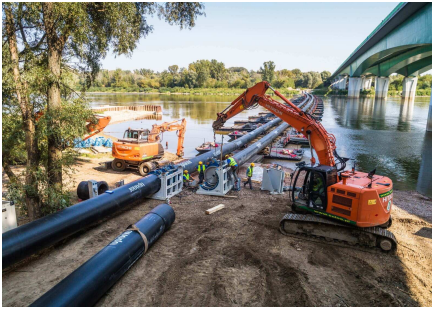
Emergency pipeline on a pontoon bridge

This time, the total length of two DN1,000mm emergency lines was 3,200 metres. Extending the pipeline by 900 metres in total made it possible to connect it directly to the Farysa treatment facility, enabling the pipeline to operate even if water levels increased on the Vistula River. The project used the same pipes as in 2019 with additional sections delivered as a matter of priority from Uponor's factory in Kleszczów. Before work began, Uponor conducted comprehensive lab tests – checking the pipes for surface scratches – as well as weld rupture strength tests. All pipes were found to be fully suited for reuse. As before, thanks to the determination and dedication of Uponor's personnel and service crews, the pipeline was fully operational within 13 days of the commission. Due to the excellent properties of the PE-HD technology, as well as failsafe

installation by means of butt welding, the pipeline had the potential to operate for years. It functioned without issues and was only disassembled again when the pontoon bridge had to be removed due to risk of damage from ice sheets forming on the river in October 2020.
