## Tailored renovation solution

The Vierimaantie road, located close to the town centre of Ylivieska, Finland has a concrete sewer line constructed in the 1960s and 1970s. A decision was taken to renovate this sewer using a tailored solution, and the product developed for this purpose is now also available to other customers.

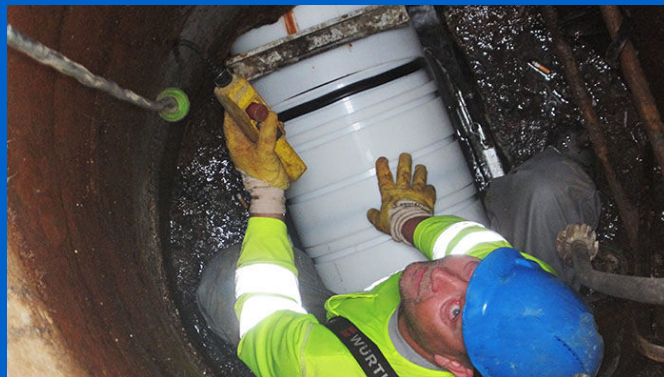
- ✓ 890 metres of VipLiner modules DN 375, with 23 drains made to measure

Uponor Infra's tailored VipLiner module provided a solution to enable the renovation of a concrete sewer line located close to the centre of Ylivieska. In addition to a new diameter size, modules were manufactured with a shorter length than standard modules, enabling the tight curves in the line to be implemented without difficulty.

VipLiner short section relining is a quick and easy way to improve the condition of old, leaking concrete sewers. A new pipe consisting of interlocking modules of 50 centimetres in length is inserted into the old pipe. If necessary, the area between the old and new pipes can be filled with autoclave foam concrete. As the renovation is completed using modules from one drain to the next, there is almost no disruption to traffic or the local environment. There is also no need for wastewater to be diverted as the pipeline can be in operation throughout the renovation. A new diameter size was developed for the VipLiner module at Uponor Infra's factory in Vaasa, Finland.
