## Emergency pipeline on a pontoon bridge

### Emergency bypass on a pontoon bridge

## A high-speed emergency task for Czajka treatment plant

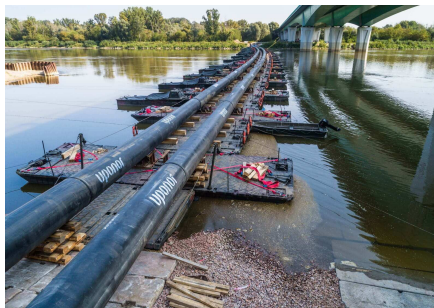
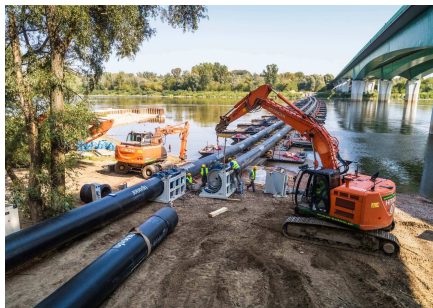
### Emergency pipeline on a pontoon bridge

This time, the total length of two DN1,000mm emergency lines was 3,200 metres. Extending the pipeline by 900 metres in total made it possible to connect it directly to the Farysa treatment facility, enabling the pipeline to operate even if water levels increased on the Vistula River. The project used the same pipes as in 2019 with additional sections delivered as a matter of priority from Uponor's factory in Kleszczów. Before work began, Uponor conducted comprehensive lab tests – checking the pipes for surface scratches – as well as weld rupture strength tests. All pipes were found to be fully suited for reuse. As before, thanks to the determination and dedication of Uponor's personnel and service crews, the pipeline was fully operational within 13 days of the commission. Due to the excellent properties of the PE-HD technology, as well as failsafe installation by means of butt welding, the pipeline had the potential to operate for years. It functioned without issues and was only disassembled again when the pontoon bridge had to be removed due to risk of damage from ice sheets forming on the river in October 2020.

Usually, projects like these take months to complete but in this case speed was of the essence. In an amazing feat, Uponor Infra was able to deliver and join the pipes required for the emergency pipeline in only eight days. The total length of the two lines of the DN1,000mm pipes was 2,200 metres, with two 250-metre sections resting on a pontoon bridge built by the Polish Army. To meet this unique challenge, Uponor mobilised all its resources: the production schedule at the company's factory in Kleszczów was adjusted to meet the urgent demand for pipes, with around-the-clock deliveries to the installation site, six service teams were delegated to the project and extra welding machines were brought in from other building sites from all over Poland. Thanks to the expertise, experience and tireless work of the Uponor crew, the new pipeline took over the functionality of the damaged collector after just 12 days, stopping the discharge of sewage into the Vistula River.
