## Tailored renovation solution

The Vierimaantie road, located close to the town centre of Ylivieska, Finland has a concrete sewer line constructed in the 1960s and 1970s. A decision was taken to renovate this sewer using a tailored solution, and the product developed for this purpose is now also available to other customers.

Location	Završetak
Ylivieska, Finland	2015
Vrsta objekta	Product systems
Gradski	Renovacija
Vrsta projekta	
Renovation

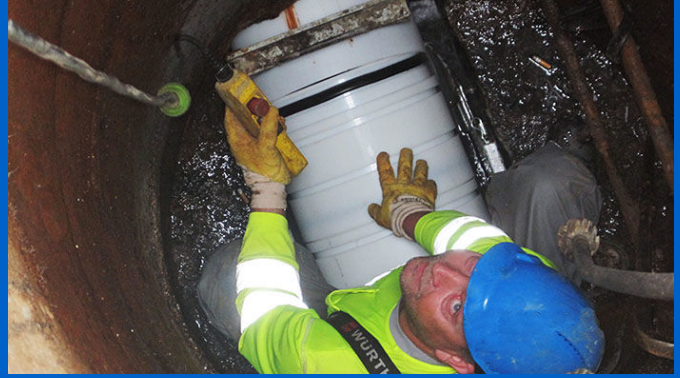
- ✓ 890 metres of VipLiner modules DN 375, with 23 drains made to measure

Uponor Infra's tailored VipLiner module provided a solution to enable the renovation of a concrete sewer line located close to the centre of Ylivieska. In addition to a new diameter size, modules were manufactured with a shorter length than standard modules, enabling the tight curves in the line to be implemented without difficulty.

VipLiner short section relining is a quick and easy way to improve the condition of old, leaking concrete sewers. A new pipe consisting of interlocking modules of 50 centimetres in length is inserted into the old pipe. If necessary, the area between the old and new pipes can be filled with autoclave foam concrete. As the renovation is completed using modules from one drain to the next, there is almost no disruption to traffic or the local environment. There is also no need for wastewater to be diverted as the pipeline can be in operation throughout the renovation. A new diameter size was developed for the VipLiner module at Uponor Infra's factory in Vaasa, Finland.
