Emergency pipeline on a pontoon bridge

Emergency bypass on a pontoon bridge

A high-speed emergency task for Czajka treatment plant

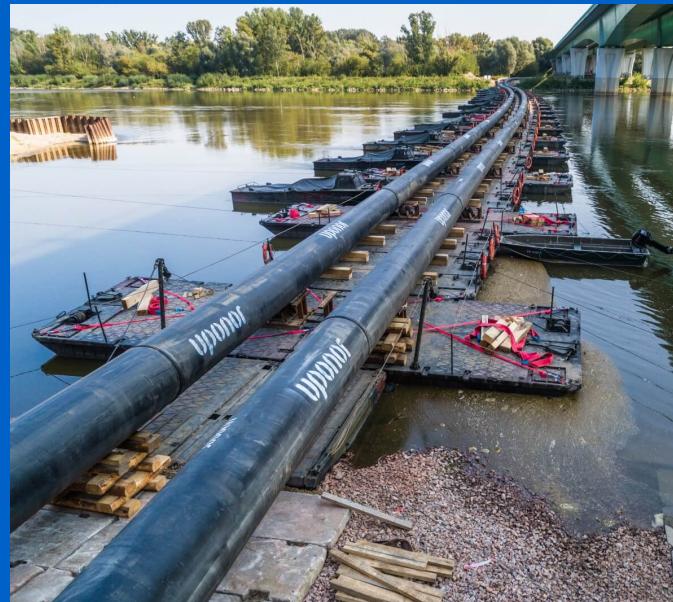
- PEHD pipes dn1000 - 3200 m
- Turnkey solution

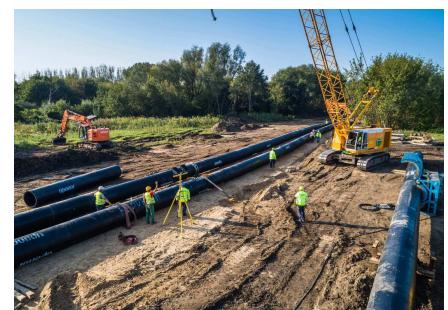
Emergency pipeline on a pontoon bridge

This time, the total length of two DN1,000mm emergency lines was 3,200 metres. Extending the pipeline by 900 metres in total made it possible to connect it directly to the Farsya treatment facility, enabling the pipeline to operate even if water levels increased on the Vistula River. The project used the same pipes as in 2019 with additional sections delivered as a matter of priority from Uponor's factory in Kleszczów. Before work began, Uponor conducted comprehensive lab tests – checking the pipes for surface scratches – as well as weld rupture strength tests. All pipes were found to be fully suited for reuse. As before, thanks to the determination and dedication of Uponor's personnel and service crews, the pipeline was fully operational within 13 days of the commission. Due to the excellent properties of the PE-HD technology, as well as failsafe installation by means of butt welding, the pipeline had the potential to operate for years. It functioned without issues and was only disassembled again when the pontoon bridge had to be removed due to risk of damage from ice sheets forming on the river in October 2020.
