Renovation of damaged stoneware collector – cracking/short relining

Renovation of damaged stoneware collector – cracking/short relining with the use of VipLiner modules

Location	Užbaigimo metai
Tomaszów Mazowiecki, Poland	2014
Pastato tipas	Product systems
Visuomeniniai pastatai	Renovacija, Sewer Municipal
Projekto tipas	
Renovation

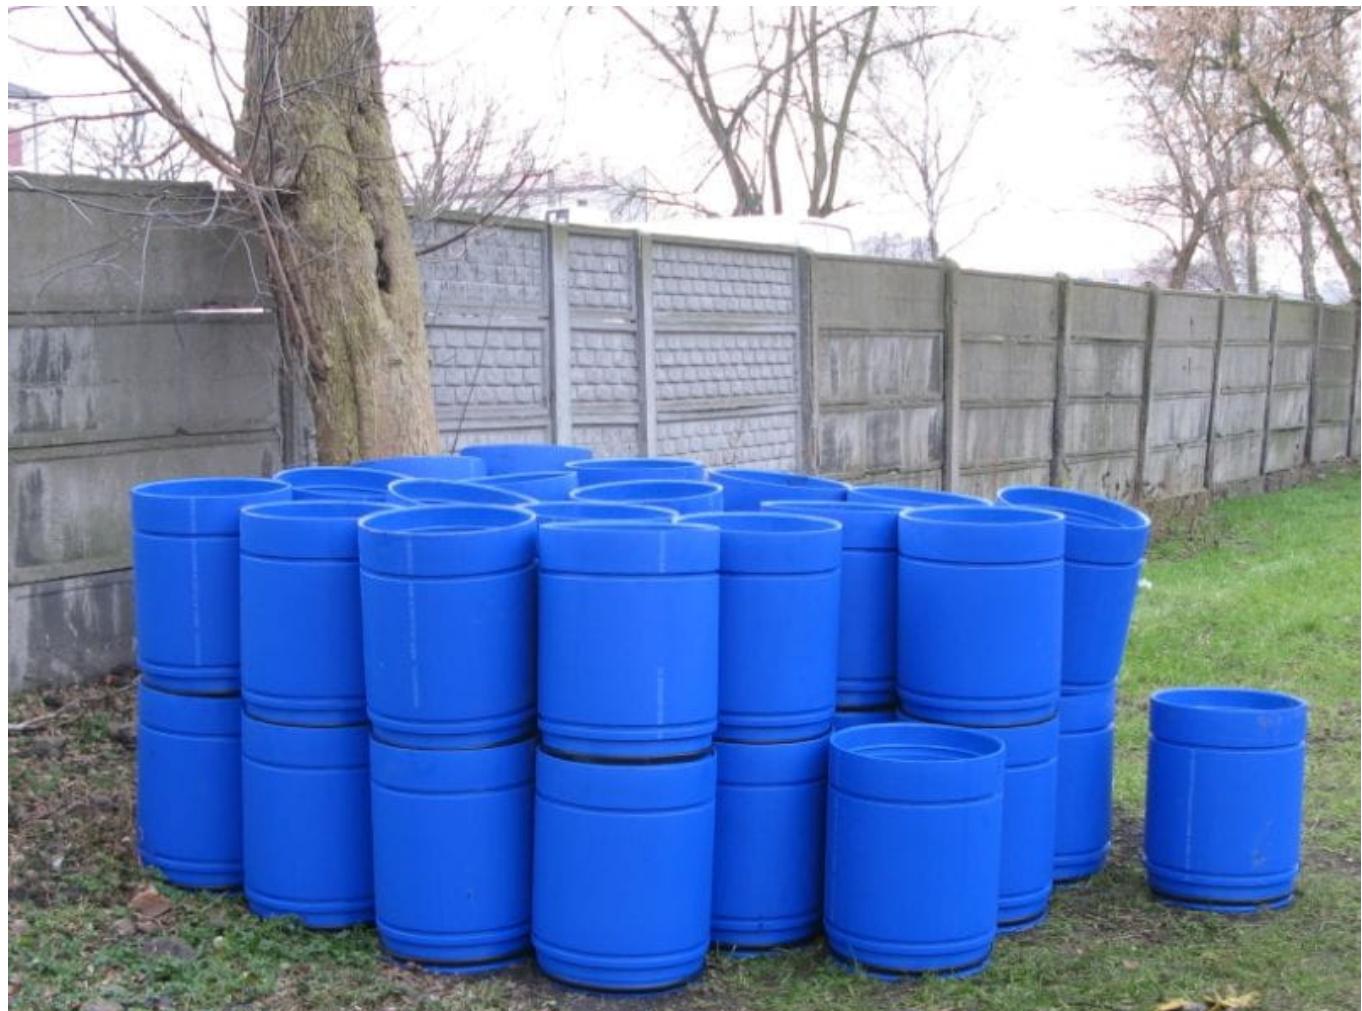
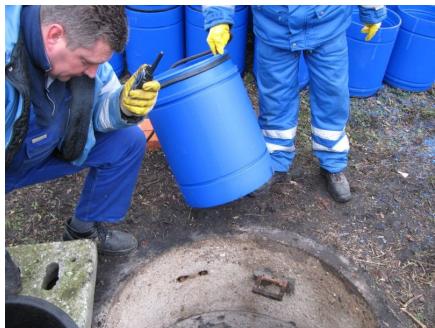
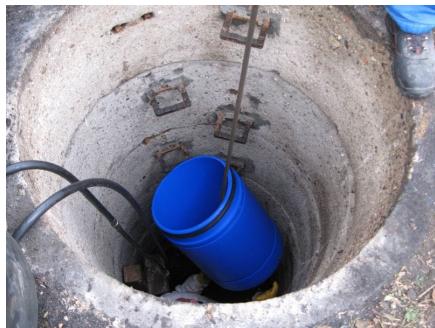
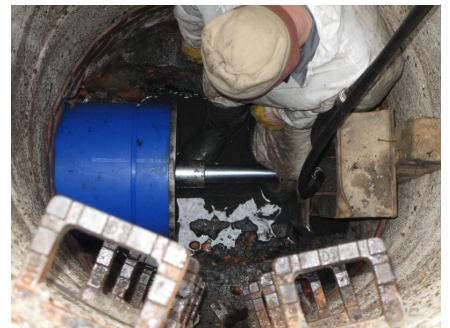
Renovation of damaged stoneware collector – cracking/short relining with the use of VipLiner modules

In Tomaszów Mazowiecki renovation of a damaged stoneware collector was carried out by means of static cracking method using VipLiner polyethylene modules. In 2013 a decision was made to carry out renovation of the stoneware collector of diameter dn250mm and dn400mm. The collector was leaking in numerous places, particularly in the places of its connection with the manholes.

Upon analysing various renovation technologies it was resolved to repair the collector with the use of VipLiner polyethylene modules PE100 RC with increased resistance to propagation of cracks, point pressure and result of scratching. Blejkan, the contractor of the project, applied the static cracking method, which concerned the crushing of the old collector with the use of the head connected by steel bolted poles with the hydraulic drive hoist and parallel insertion of VipLiner modules after the head. This method allowed to improve the hydraulic parameters of the sewage network. Uponor Infra delivered for this investment VipLiner modules of 0.5 m length and diameter respectively higher than the renovated section (dn355 and 450mm).

The works were carried out in winter at the turn of 2013/2014. The renovation included 8 sections and the longest section between the manholes was 60 m. The contractor commended the easy and simple nature of installation of the modules and the speed of works using VipLiner modules (the average renovation time of a section was approx. 3 days).
