## Emergency pipeline on a pontoon bridge

## Emergency bypass on a pontoon bridge

## A high-speed emergency task for Czajka treatment plant

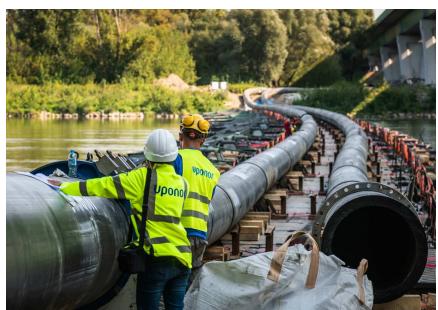
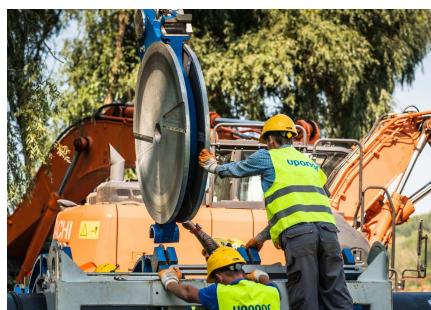
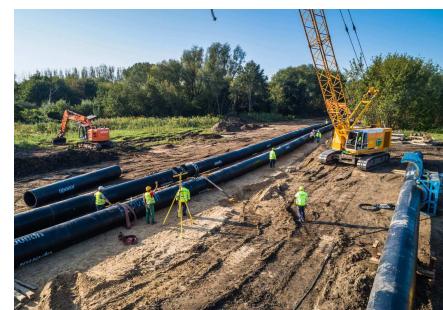
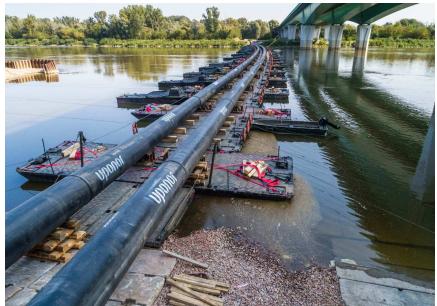
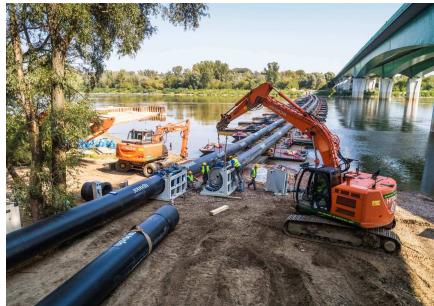
### Emergency pipeline on a pontoon bridge

This time, the total length of two DN1,000mm emergency lines was 3,200 metres. Extending the pipeline by 900 metres in total made it possible to connect it directly to the Farsya treatment facility, enabling the pipeline to operate even if water levels increased on the Vistula River. The project used the same pipes as in 2019 with additional sections delivered as a matter of priority from Uponor's factory in Kleszczów. Before work began, Uponor conducted comprehensive lab tests – checking the pipes for surface scratches – as well as weld rupture strength tests. All pipes were found to be fully suited for reuse. As before, thanks to the determination and dedication of Uponor's personnel and service crews, the pipeline was fully operational within 13 days of the commission. Due to the excellent properties of the PE-HD technology, as well as failsafe installation by means of butt welding, the pipeline had the potential to operate for years. It functioned without issues and was only disassembled again when the pontoon bridge had to be removed due to risk of damage from ice sheets forming on the river in October 2020.
