Emergency pipeline on a pontoon bridge

Emergency bypass on a pontoon bridge

A high-speed emergency task for Czajka treatment plant

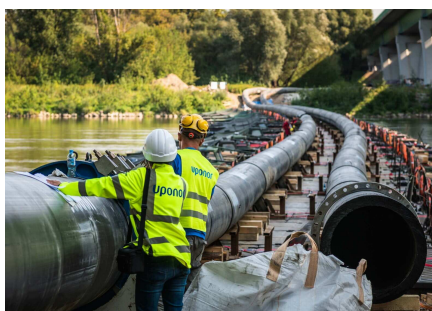
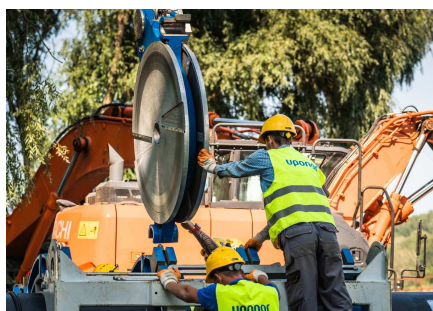
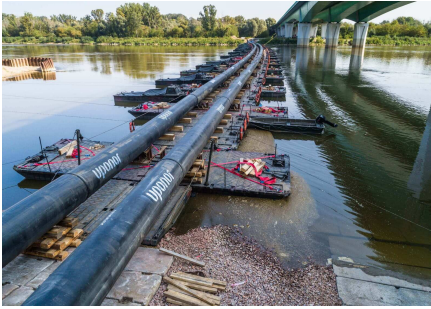
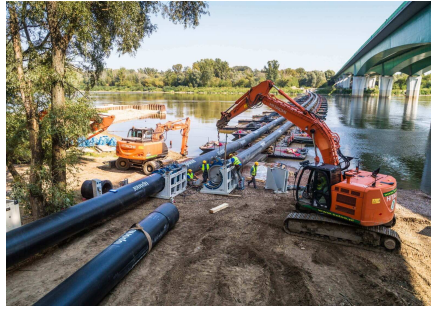
Emergency pipeline on a pontoon bridge

This time, the total length of two DN1,000mm emergency lines was 3,200 metres. Extending the pipeline by 900 metres in total made it possible to connect it directly to the Farysa treatment facility, enabling the pipeline to operate even if water levels increased on the Vistula River. The project used the same pipes as in 2019 with additional sections delivered as a matter of priority from Uponor's factory in Kleszczów. Before work began, Uponor conducted comprehensive lab tests – checking the pipes for surface scratches – as well as weld rupture strength tests. All pipes were found to be fully suited for reuse. As before, thanks to the determination and dedication of Uponor's personnel and service crews, the pipeline was fully operational within 13 days of the commission. Due to the excellent properties of the PE-HD technology, as well as failsafe installation by means of butt welding, the pipeline had the potential to operate for years. It functioned without issues and was only disassembled again when the pontoon bridge had to be removed due to risk of damage from ice sheets forming on the river in October 2020.
