Emergency pipeline on a pontoon bridge

Emergency bypass on a pontoon bridge

A high-speed emergency task for Czajka treatment plant

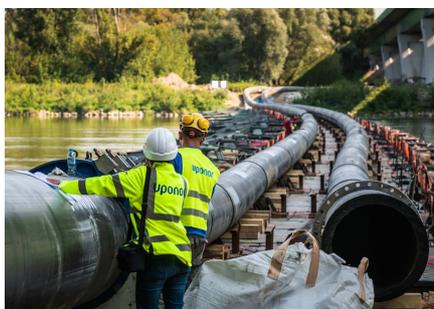
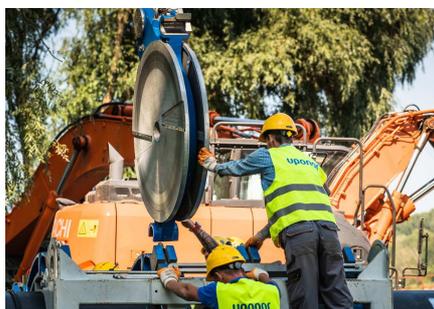
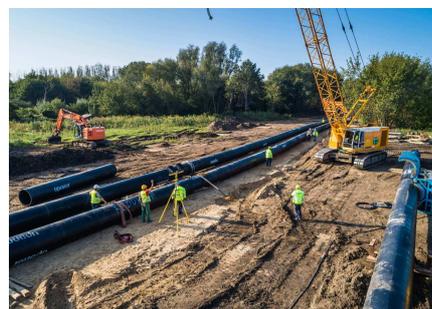
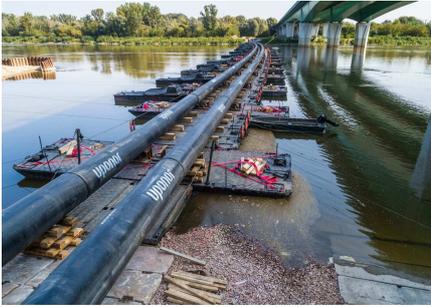
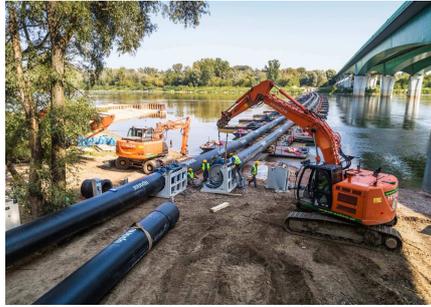
Emergency pipeline on a pontoon bridge

This time, the total length of two DN1,000mm emergency lines was 3,200 metres. Extending the pipeline by 900 metres in total made it possible to connect it directly to the Farysa treatment facility, enabling the pipeline to operate even if water levels increased on the Vistula River. The project used the same pipes as in 2019 with additional sections delivered as a matter of priority from Uponor's factory in Kleszczów. Before work began, Uponor conducted comprehensive lab tests – checking the pipes for surface scratches – as well as weld rupture strength tests. All pipes were found to be fully suited for reuse. As before, thanks to the determination and dedication of Uponor's personnel and service crews, the pipeline was fully operational within 13 days of the commission. Due to the excellent properties of the PE-HD technology, as well as failsafe installation by means of butt welding, the pipeline had the potential to operate for years. It functioned without issues and was only disassembled again when the pontoon bridge had to be removed due to risk of damage from ice sheets forming on the river in October 2020.
