## Emergency pipeline on a pontoon bridge

### Emergency bypass on a pontoon bridge

## A high-speed emergency task for Czajka treatment plant

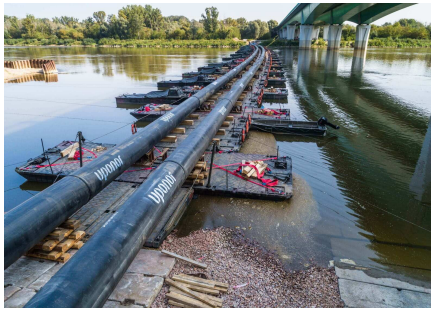
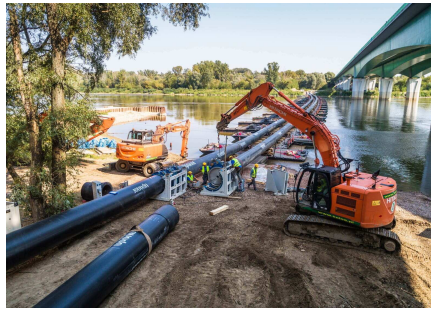
### Emergency pipeline on a pontoon bridge

This time, the total length of two DN1,000mm emergency lines was 3,200 metres. Extending the pipeline by 900 metres in total made it possible to connect it directly to the Farysa treatment facility, enabling the pipeline to operate even if water levels increased on the Vistula River. The project used the same pipes as in 2019 with additional sections delivered as a matter of priority from Uponor's factory in Kleszczów. Before work began, Uponor conducted comprehensive lab tests – checking the pipes for surface scratches – as well as weld rupture strength tests. All pipes were found to be fully suited for reuse. As before, thanks to the determination and dedication of Uponor's personnel and service crews, the pipeline was fully operational within 13 days of the commission. Due to the excellent properties of the PE-HD technology, as well as failsafe installation by means of butt welding, the pipeline had the potential to operate for years. It functioned without issues and was only disassembled again when the pontoon bridge had to be removed due to risk of damage from ice sheets forming on the river in October 2020.
