Renovation of damaged stoneware collector – cracking/short relining

Renovation of damaged stoneware collector – cracking/short relining with the use of VipLiner modules

In Tomaszów Mazowiecki renovation of a damaged stoneware collector was carried out by means of static cracking method using VipLiner polyethylene modules

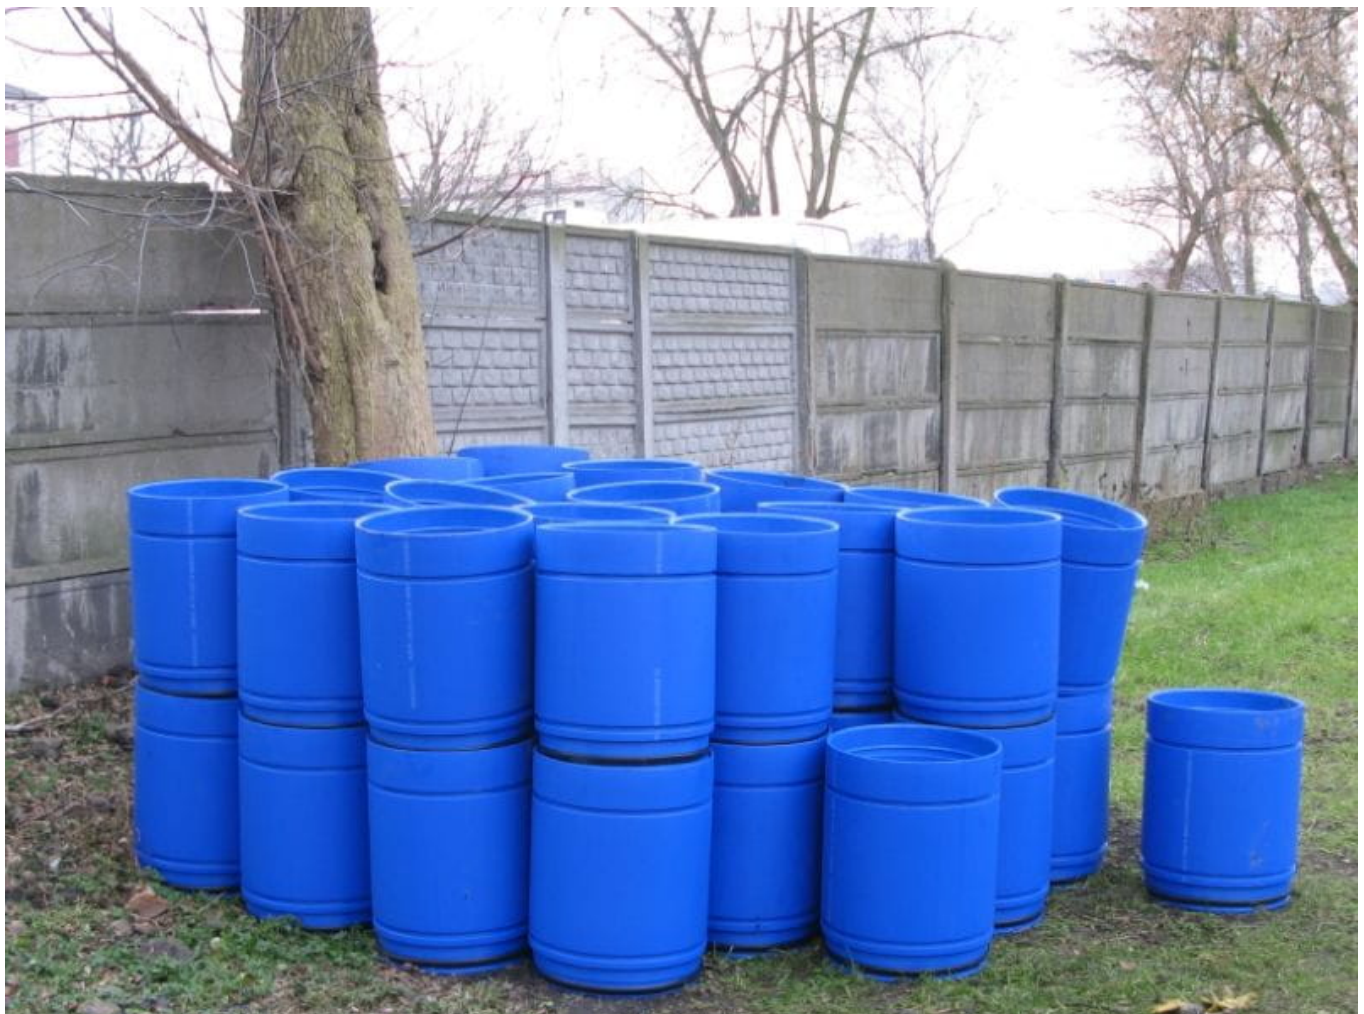
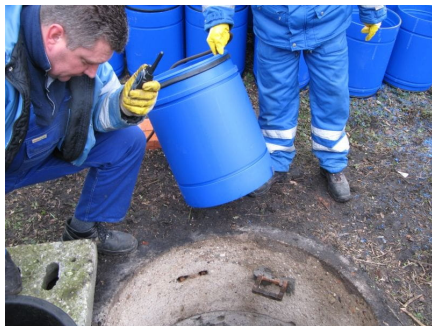
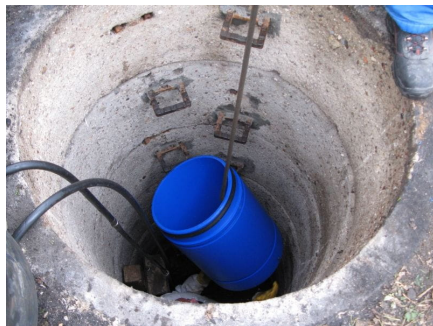
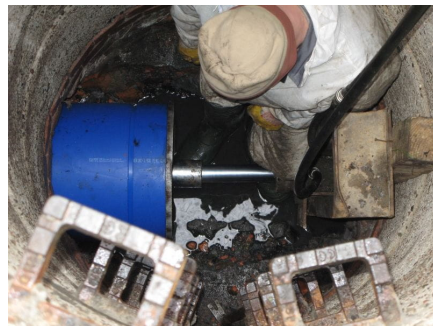
Renovation of damaged stoneware collector – cracking/short relining with the use of VipLiner modules

Upon analysing various renovation technologies it was resolved to repair the collector with the use of VipLiner polyethylene modules PE100 RC with increased resistance to propagation of cracks, point pressure and result of scratching, Blejkan, the contractor of the project, applied the static cracking method, which concerned the crushing of the old collector with the use of the head connected by steel bolted poles with the hydraulic drive hoist and parallel insertion of VipLiner modules after the head. This method allowed to improve the hydraulic parameters of the sewage network. Uponor Infra delivered for this investment VipLiner modules of 0.5 m length and diameter respectively higher than the renovated section (dn355 and 450mm).

The works were carried out in winter at the turn of 2013/2014. The renovation included 8 sections and the longest section between the manholes was 60 m. The contractor commended the easy and simple nature of installation of the modules and the speed of works using VipLiner modules (the average renovation time of a section was approx. 3 days).
