## Renovation of damaged stoneware collector – cracking/short relining

## Renovation of damaged stoneware collector – cracking/short relining with the use of VipLiner modules

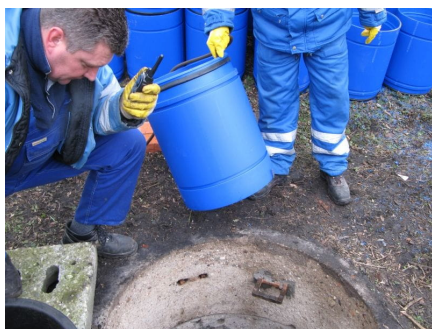
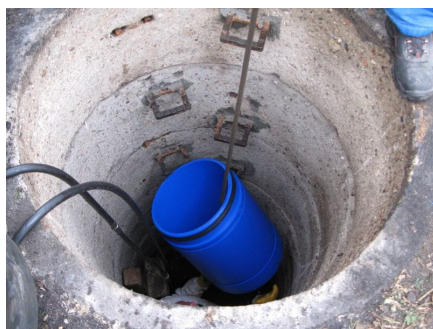
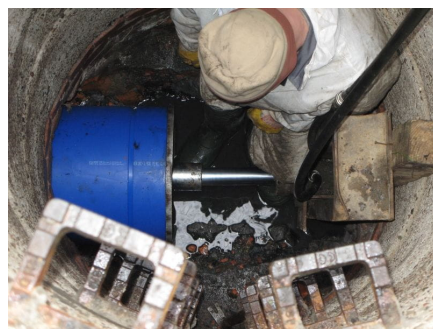
## **Renovation of damaged stoneware collector – cracking/short relining with the use of VipLiner modules**

In Tomaszów Mazowiecki renovation of a damaged stoneware collector was carried out by means of static cracking method using VipLiner polyethylene modules. In 2013 a decision was made to carry out renovation of the stoneware collector of diameter dn250mm and dn400mm. The collector was leaking in numerous places, particularly in the places of its connection with the manholes.

Upon analysing various renovation technologies it was resolved to repair the collector with the use of VipLiner polyethylene modules PE100 RC with increased resistance to propagation of cracks, point pressure and result of scratching, Blejkan, the contractor of the project, applied the static cracking method, which concerned the crushing of the old collector with the use of the head connected by steel bolted poles with the hydraulic drive hoist and parallel insertion of VipLiner modules after the head. This method allowed to improve the hydraulic parameters of the sewage network. Uponor Infra delivered for this investment VipLiner modules of 0.5 m length and diameter respectively higher than the renovated section (dn355 and 450mm).

The works were carried out in winter at the turn of 2013/2014. The renovation included 8 sections and the longest section between the manholes was 60 m. The contractor commended the easy and simple nature of installation of the modules and the speed of works using VipLiner modules (the average renovation time of a section was approx. 3 days).
