Renovation of damaged stoneware collector – cracking/short relining

Renovation of damaged stoneware collector – cracking/short relining with the use of VipLiner modules

In Tomaszów Mazowiecki renovation of a damaged stoneware collector was carried out by means of static cracking method using VipLiner polyethylene modules

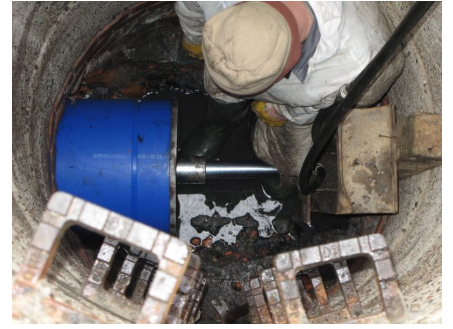
In Tomaszów Mazowiecki renovation of a damaged stoneware collector was carried out by means of static cracking method using VipLiner polyethylene modules. In 2013 a decision was made to carry out renovation of the stoneware collector of diameter dn250mm and dn400mm. The collector was leaking in numerous places, particularly in the places of its connection with the manholes.

Upon analysing various renovation technologies it was resolved to repair the collector with the use of VipLiner polyethylene modules PE100 RC with increased resistance to propagation of cracks, point pressure and result of scratching, Blejkan, the contractor of the project, applied the static cracking method, which concerned the crushing of the old collector with the use of the head connected by steel bolted poles with the hydraulic drive hoist and parallel insertion of VipLiner modules after the head. This method allowed to improve the hydraulic parameters of the sewage network. Uponor Infra delivered for this investment VipLiner modules of 0.5 m length and diameter respectively higher than the renovated section (dn355 and 450mm).

The works were carried out in winter at the turn of 2013/2014. The renovation included 8 sections and the longest section between the manholes was 60 m. The contractor commended the easy and simple nature of installation of the modules and the speed of works using VipLiner modules (the average renovation time of a section was approx. 3 days).
