Renovation of damaged stoneware collector – cracking/short relining

Renovation of damaged stoneware collector – cracking/short relining with the use of VipLiner modules

In Tomaszów Mazowiecki renovation of a damaged stoneware collector was carried out by means of static cracking method using VipLiner polyethylene modules

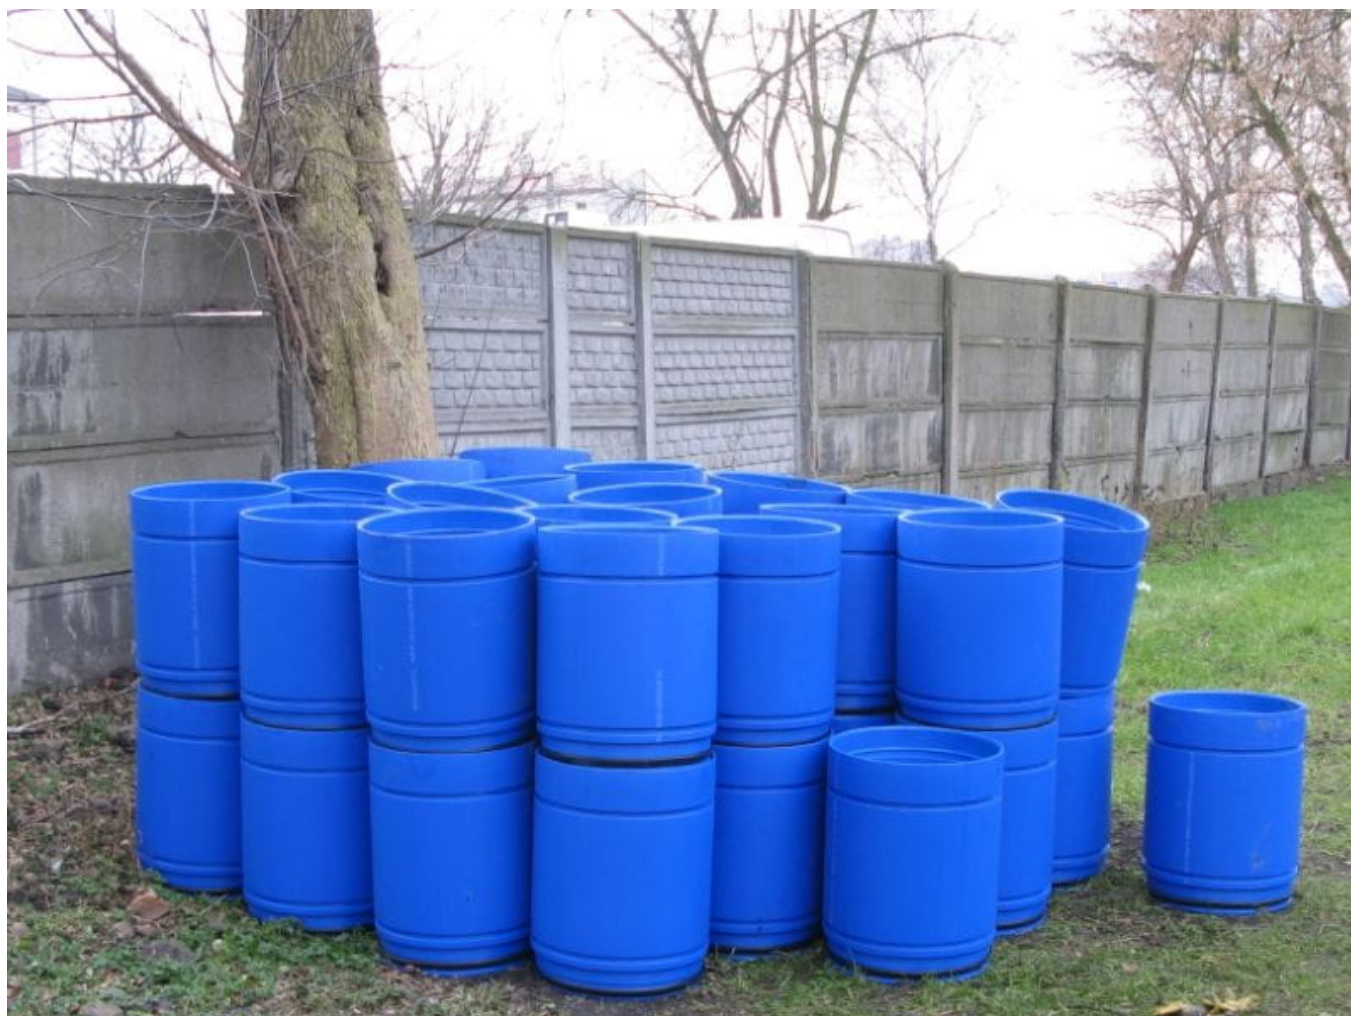
Renovation of damaged stoneware collector – cracking/short relining with the use of VipLiner modules

In Tomaszów Mazowiecki renovation of a damaged stoneware collector was carried out by means of static cracking method using VipLiner polyethylene modules. In 2013 a decision was made to carry out renovation of the stoneware collector of diameter dn250mm and dn400mm. The collector was leaking in numerous places, particularly in the places of its connection with the manholes.

Upon analysing various renovation technologies it was resolved to repair the collector with the use of VipLiner polyethylene modules PE100 RC with increased resistance to propagation of cracks, point pressure and result of scratching, Blejkan, the contractor of the project, applied the static cracking method, which concerned the crushing of the old collector with the use of the head connected by steel bolted poles with the hydraulic drive hoist and parallel insertion of VipLiner modules after the head. This method allowed to improve the hydraulic parameters of the sewage network. Uponor Infra delivered for this investment VipLiner modules of 0.5 m length and diameter respectively higher than the renovated section (dn355 and 450mm).

The works were carried out in winter at the turn of 2013/2014. The renovation included 8 sections and the longest section between the manholes was 60 m. The contractor commended the easy and simple nature of installation of the modules and the speed of works using VipLiner modules (the average renovation time of a section was approx. 3 days).
