Quick installation in the Konotopa channel

Weholite pipes PEHD SN4 DN2000 mm – 165 m

Weholite guaranteed a simple and quick installation in the Konotopa channel

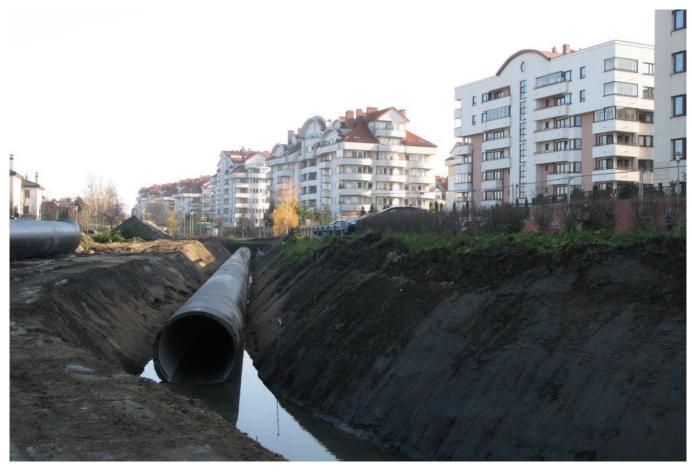
Weholite guaranteed a simple and quick installation in the Konotopa channel

Following a tender, in September 2016 Drainage Construction Company Tolos was appointed as the general contractor for the project. Uponor Infra delivered a total of 165 metres of structured-wall PE-HD Weholite, DN/ID 2,000mm SN4 pipes to the installation site. Prep work included clearing the channel of concrete slab lining, dredging the ditch to make room for the new pipeline and laying the bedding. Uponor Infra pipe service staff then joined up the Weholite pipes to form two sections. The work was carried out on dry land on the right bank of the channel, by means of automatic extrusion welding using a WLI-3000 machine. This guaranteed the 100% tightness and homogeneity of the pipeline. A 100- metre section of pipeline was then lowered into the ditch, followed by the remaining 50-metre section with a fitted bend two days later. Since the channel was operational during installation, the two connecting sections of the pipeline were raised above the water level, where they were welded together. The pipeline was then connected to a reinforced concrete inlet of the underground section of the channel. A socket- and- spigot DN/ID200mm joint was fitted onto the pipeline, connecting it to an existing stormwater channel. Finally, the ditch was backfilled. At the spot where the new pipeline meets the open section of the channel, an outlet was secured with a steel grate to prevent unauthorised entry. The installation was completed in December 2016.
