Renovation of damaged stoneware collector – cracking/short relining

Renovation of damaged stoneware collector – cracking/short relining with the use of VipLiner modules

In Tomaszów Mazowiecki renovation of a damaged stoneware collector was carried out by means of static cracking method using VipLiner polyethylene modules

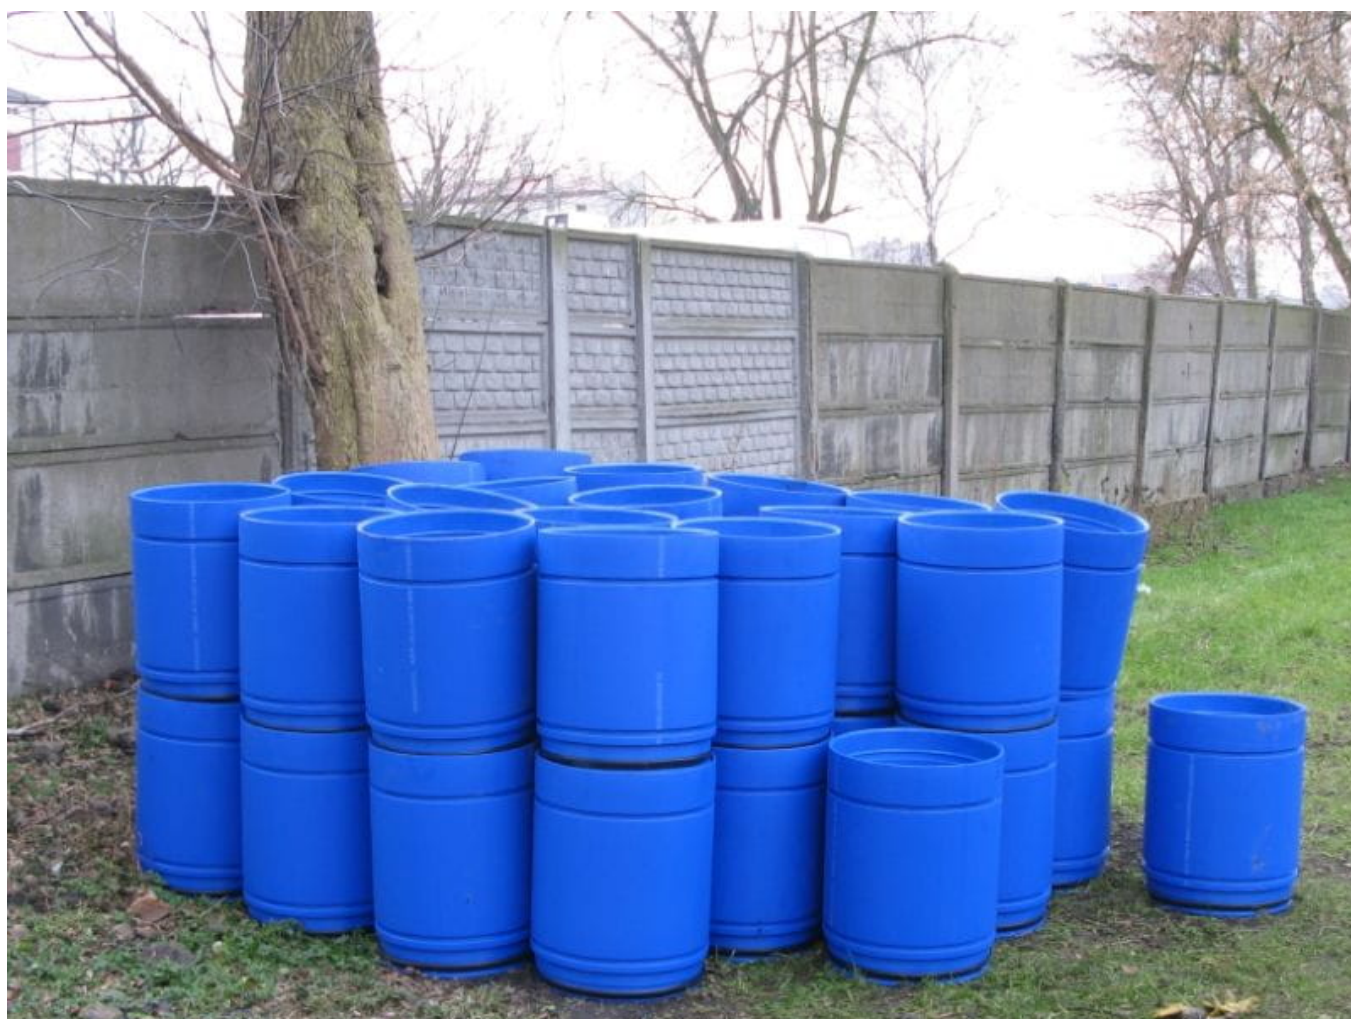
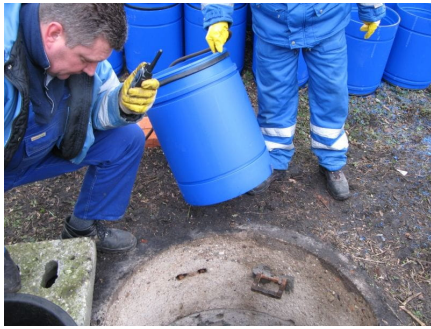
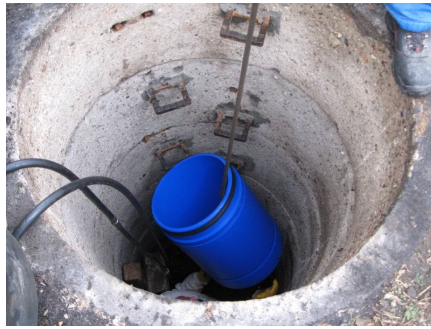
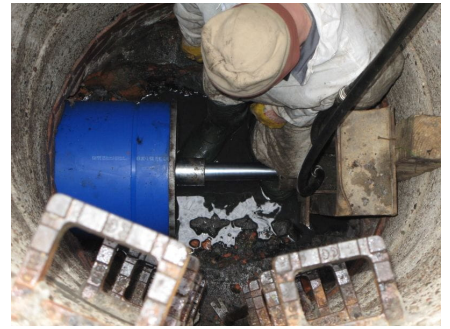
Renovation of damaged stoneware collector – cracking/short relining with the use of VipLiner modules

In Tomaszów Mazowiecki renovation of a damaged stoneware collector was carried out by means of static cracking method using VipLiner polyethylene modules. In 2013 a decision was made to carry out renovation of the stoneware collector of diameter dn250mm and dn400mm. The collector was leaking in numerous places, particularly in the places of its connection with the manholes.

Upon analysing various renovation technologies it was resolved to repair the collector with the use of VipLiner polyethylene modules PE100 RC with increased resistance to propagation of cracks, point pressure and result of scratching, Blejkan, the contractor of the project, applied the static cracking method, which concerned the crushing of the old collector with the use of the head connected by steel bolted poles with the hydraulic drive hoist and parallel insertion of VipLiner modules after the head. This method allowed to improve the hydraulic parameters of the sewage network. Uponor Infra delivered for this investment VipLiner modules of 0.5 m length and diameter respectively higher than the renovated section (dn355 and 450mm).

The works were carried out in winter at the turn of 2013/2014. The renovation included 8 sections and the longest section between the manholes was 60 m. The contractor commended the easy and simple nature of installation of the modules and the speed of works using VipLiner modules (the average renovation time of a section was approx. 3 days).
