Plastic pipe withstands mill's process water

Stora Enso's Imatra mill, located in southeast Finland, annually produces one million tonnes of packaging paper and board. The Imatra mill's two production units produce raw materials for cartons, in which juice and milk are packaged. Board is also used to produce paper cups, as well as cigarette and candy packages. Board for the graphics industry is used to produce cards, covers and luxury packages.

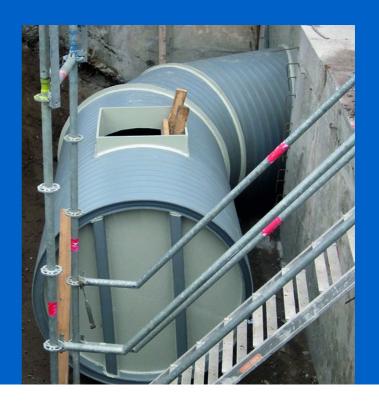
Plastic pipe withstands mill's process water

During the first stage, seventy metres of pipe, with a diameter of 1.6 metres, was installed at the mill. The pipe was slid into the existing concrete channel. Additionally, two segment bends were installed in preparation for the project's second stage. At that time, a further 120 metres of pipe will be added to the system and buried underground. As the pipeline will curve back and forth, completion of the installation work will require the addition of five or six segment bends. Dite manager Kimmo Sjöman oversaw the preparation and installation work during the first stage of the project at Imatra.

According to Mr Sjöman, sliding the stiff pipe into a square tunnel was somewhat difficult, as there was little space and the pipe did not bend easily. The outside diameter of the pipe was 1.8 metres. The pipe was slid into a square tunnel that was 2 x 2 metres in size.

"It was a tight fit, but we were successful," Mr Sjöman recounted. During the slip lining procedure, a wire was attached to one end of the pipe, which made it possible to pull the pipe into the tunnel.

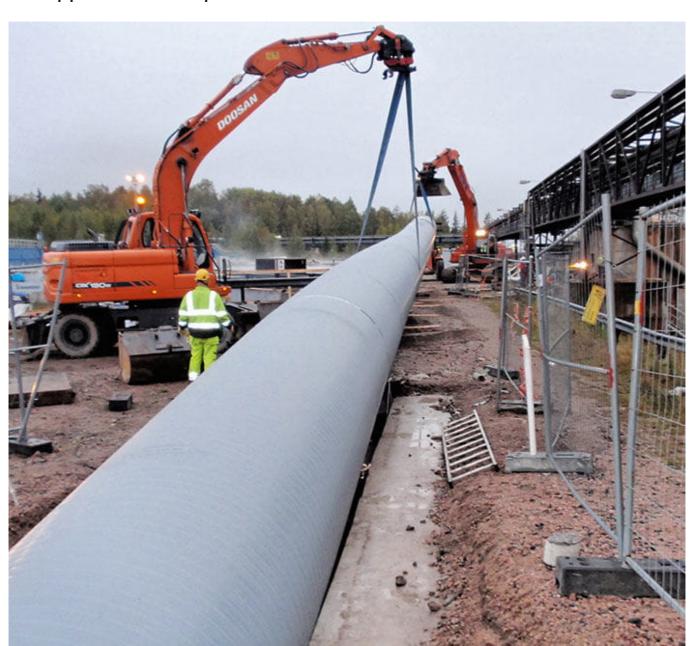
Plastic pipe withstands mill's process water
