## Water treatment plant

### Aeration tank to improve the water quality

Water company Ylä-Savon Vesi Oy needed a solution to improve the water quality in water supply process. The solution was an aeration tank made of Weholite.

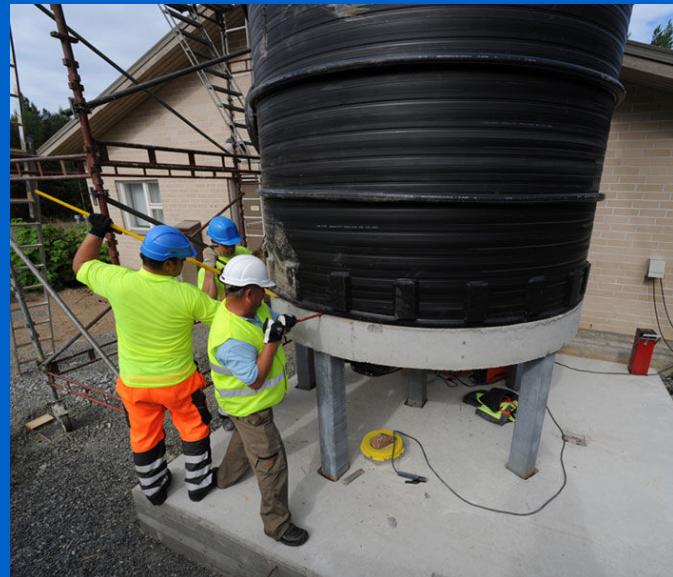
- 2.4 m diameter Weholite tank

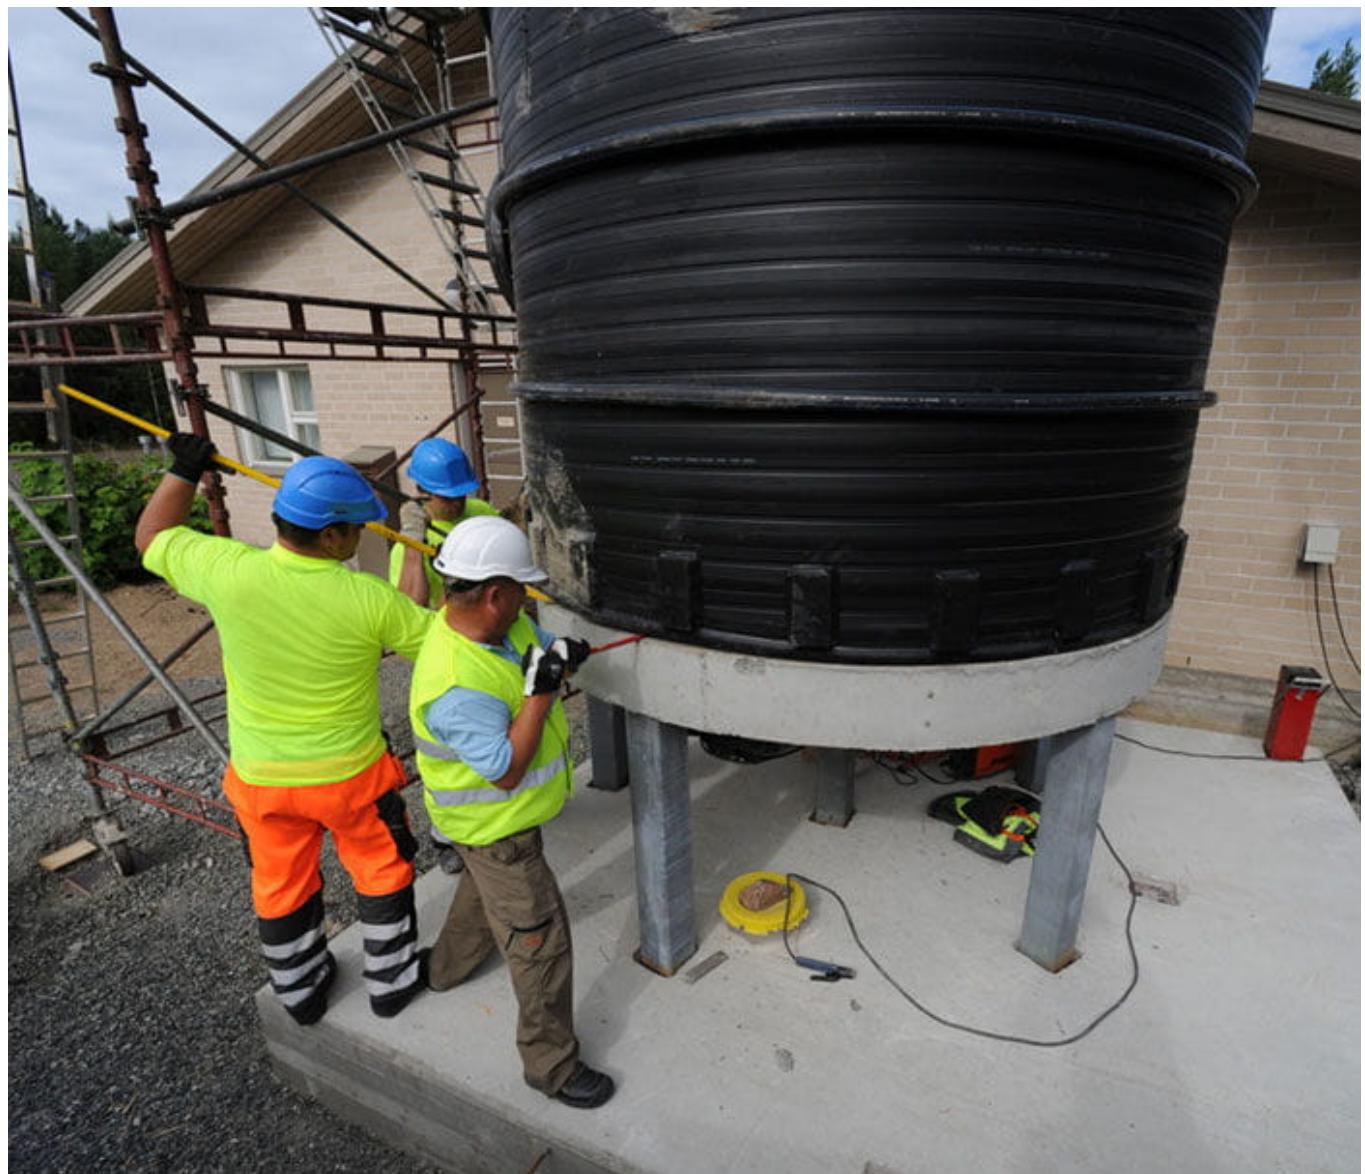
## Weholite aeration tank

In aeration that improves water quality, water is led to the tower from above. The water flows through the infill mattress in the tower, removing the carbon dioxide in the raw water. Aeration can be adjusted by blowing clean air under the tower through the mattress upstream.

The amount of air does not require the tower to withstand greater pressure than normal in normal use, but the Weholite tank can also withstand the full water pressure of the tank, for example in the event of washing or disturbances.
