Referenzen

Water treatment plant

Aeration tank to improve the water quality

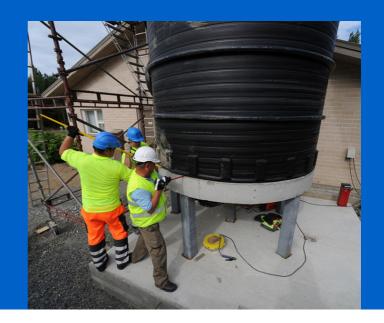
2.4 m diameter Weholite tank
