# Water treatment plant

## Aeration tank to improve the water quality

Water company Ylä-Savon Vesi Oy needed a solution to improve the water quality in water supply process. The solution was an aeration tank made of Weholite.

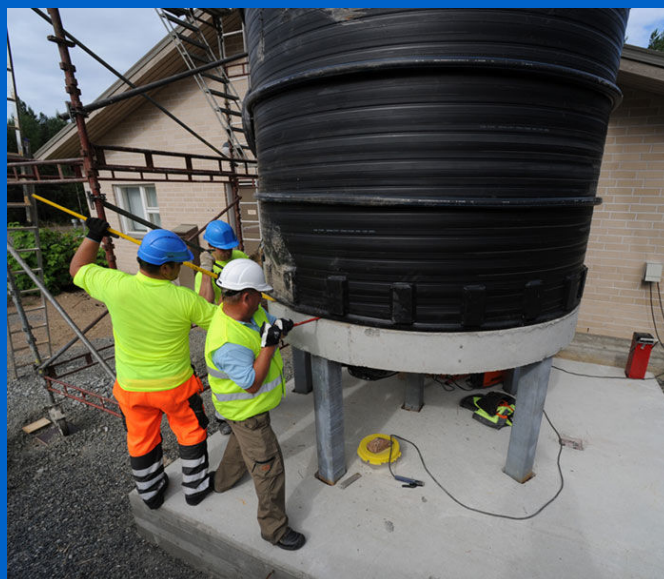
2.4 m diameter Weholite tank

In aeration that improves water quality, water is led to the tower from above. The water flows through the infill mattress in the tower, removing the carbon dioxide in the raw water. Aeration can be adjusted by blowing clean air under the tower through the mattress upstream.

- The concrete slab under the tower had already been made in advance. On top of the base slab, we installed feet just over a meter high, on which we lifted a round concrete slab. The tower was attached to it, says work manager Kalevi Savolainen.
