# Water treatment plant

## Aeration tank to improve the water quality

Water company Ylä-Savon Vesi Oy needed a solution to improve the water quality in water supply process. The solution was an aeration tank made of Weholite.

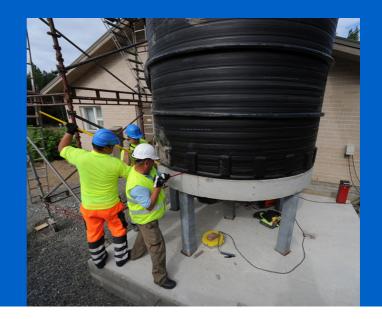
2.4 m diameter Weholite tank

- We also had the idea that aeration towers would complement the products of the water supply system well. The contact of Ylä-Savo water thus came in a good seam. Our technical advice had time to think of a solution in peace. The cooperation went very well from start to finish. The aeration tower was built at the Vaasa plant from a 2.4-meter Weholite pipe.
