Getting rid of indoor radon

Uponor's radon system was installed in a detached house in Ilomantsi, completed in 1987. Previously, the radon values in the house were 1,188 becquerels. After installing the system, the radon values dropped to 83.

Project Facts:

Location	Completion
Ilomantsi, Finland	2014
Building Type	Product systems
Single homes	Ventilation
Project Type	
New building

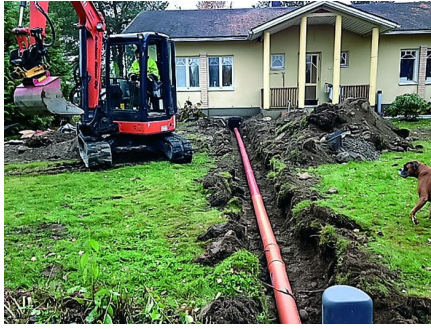
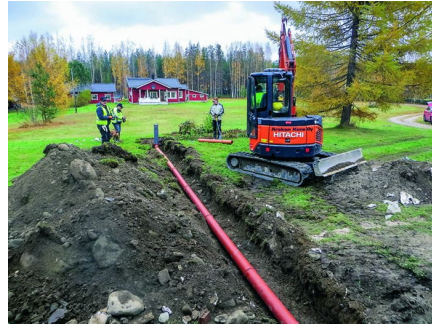
Eroon sisailman radonista

The installation contract went quickly and easily in one working day. The work began with the excavation of a well of about three and a half meters. At the bottom of the well came crushed stone and a vacuum cleaner, from which came about a 15-meter drainage pipe.

An exhaust air fan built into the system creates a vacuum under the house, which absorbs radon gas into the suction duct and moves it out of the vicinity of the house in a controlled and safe manner along the exhaust duct.
