## Water treatment plant

2.4 m diameter Weholite tank

### Aeration tank to improve the water quality

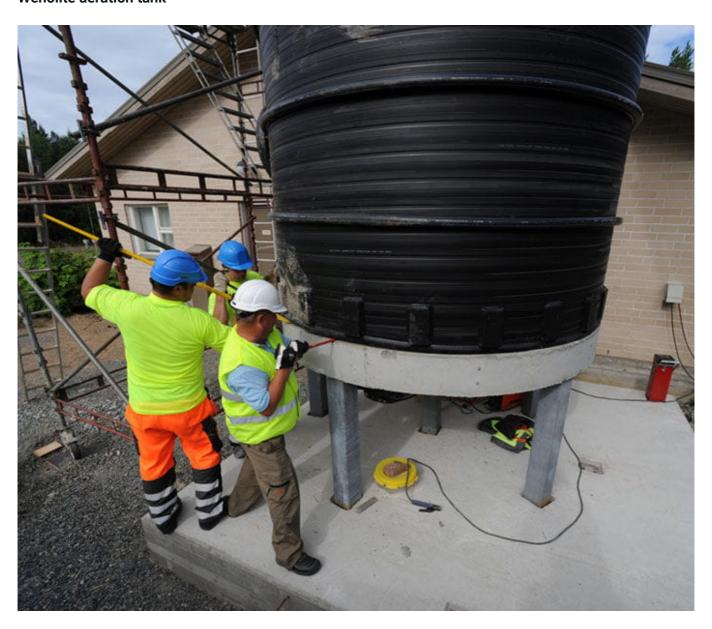
#### Weholite aeration tank

In aeration that improves water quality, water is led to the tower from above. The water flows through the infill mattress in the tower, removing the carbon dioxide in the raw water. Aeration can be adjusted by blowing clean air under the tower through the mattress upstream.

The amount of air does not require the tower to withstand greater pressure than normal in normal use, but the Weholite tank can also withstand the full water pressure of the tank, for example in the event of washing or disturbances.

- As the tank could not be installed indoors, hygiene had to be taken into account in its design: no free openings could be left. The service hatches must be tight, as outdoor air pollutants must not get into the domestic water, Pekka livari reminds.

- The concrete slab under the tower had already been made in advance. On top of the base slab, we installed feet just over a meter high, on which we lifted a round concrete slab. The tower was attached to it, says work manager Kalevi Savolainen.

Valves and piping were installed in the space under the tower. The insulation of the lower part was also supplemented. The finished tower was raised with a truck crane. - The work went as planned. Already during the installation work, guests visited the site. The insulated aeration tank is interesting because there is little space for such massive structures in a few places, Savolainen says. The contractor completed the tower by installing exterior cladding.
