## Plastic pipe withstands mill's process water

#### Project Facts:

Imatra, Finland

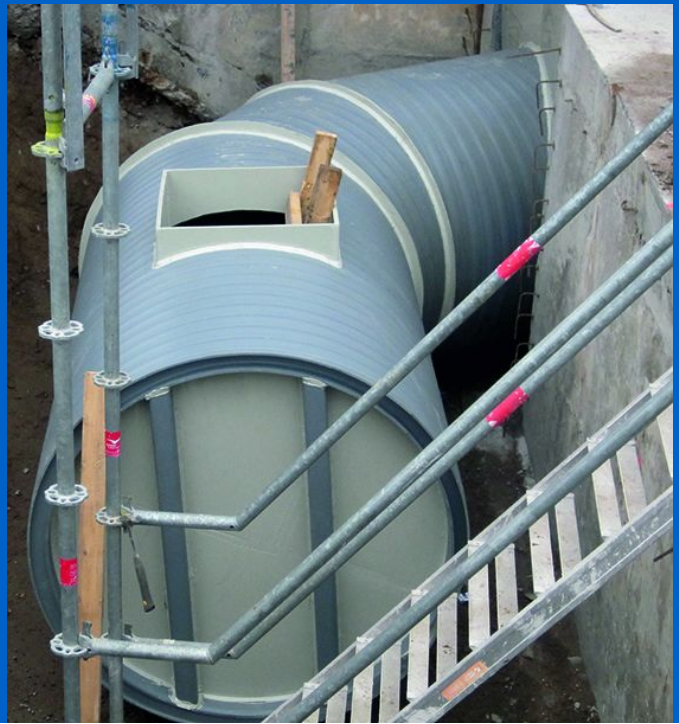
The process water required in the manufacture of board and paper has thus far run through concrete channels to the treatment process facility, after which the water has been discharged into Lake Saimaa. The hot water that contains chemicals has worn down and eroded the concrete structures so much that a new solution had to be found for transporting the process water.

During the first stage, seventy metres of pipe, with a diameter of 1.6 metres, was installed at the mill. The pipe was slid into the existing concrete channel. Additionally, two segment bends were installed in preparation for the project's second stage. At that time, a further 120 metres of pipe will be added to the system and buried underground. As the pipeline will curve back and forth, completion of the installation work will require the addition of five or six segment bends. Dite manager Kimmo Sjöman oversaw the preparation and installation work during the first stage of the project at Imatra.

According to Mr Sjöman, sliding the stiff pipe into a square tunnel was somewhat difficult, as there was little space and the pipe did not bend easily. The outside diameter of the pipe was 1.8 metres. The pipe was slid into a square tunnel that was 2 x 2 metres in size.

"It was a tight fit, but we were successful," Mr Sjöman recounted. During the slip lining procedure, a wire was attached to one end of the pipe, which made it possible to pull the pipe into the tunnel.

Excavators then pushed the piping into the concrete channel. According to Mr Sjöman and Mr Tiilikainen, the installation was completed successfully and within the agreed timeframe. However, there were small setbacks during commissioning, when a small leak was observed in an inspection chamber. The cause of this leak was fixed by sealing up the welding seams. Everything was ready for the project's second sta

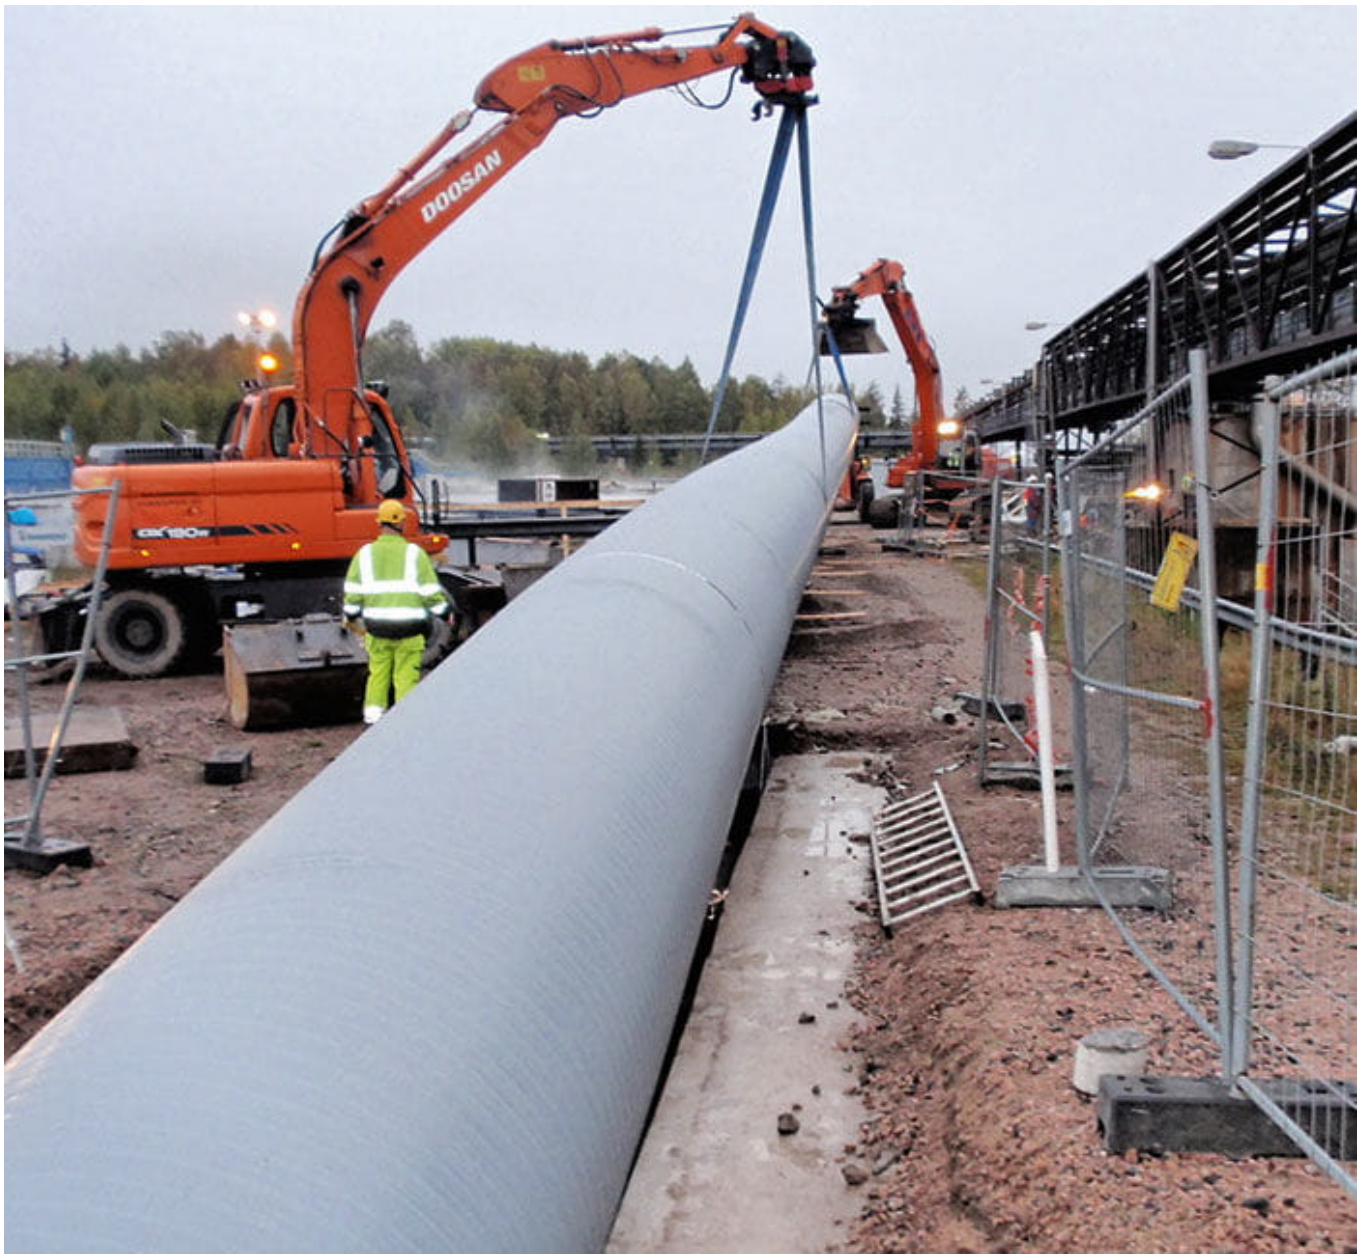
Weholite pipe is manufactured by spiral welding PE or PP profiles. Polypropylene pipe is suited for use in instances where the pipe must withstand high temperatures.

Polypropylene pipe is slightly stiffer than polyethylene pipe. This is an advantage in some situations and a disadvantage in others. And this was the case at Imatra: "We specifically wanted a stiff pipe at the Imatra site, because, at points, the piping runs close to the earth's surface and is therefore subject to traffic load," Mr Andtbacka says.
