Plastic pipe withstands mill's process water

Stora Enso's Imatra mill, located in southeast Finland, annually produces one million tonnes of packaging paper and board. The Imatra mill's two production units produce raw materials for cartons, in which juice and milk are packaged. Board is also used to produce paper cups, as well as cigarette and candy packages. Board for the graphics industry is used to produce cards, covers and luxury packages.

The process water required in the manufacture of board and paper has thus far run through concrete channels to the treatment process facility, after which the water has been discharged into Lake Saimaa. The hot water that contains chemicals has worn down and eroded the concrete structures so much that a new solution had to be found for transporting the process water.

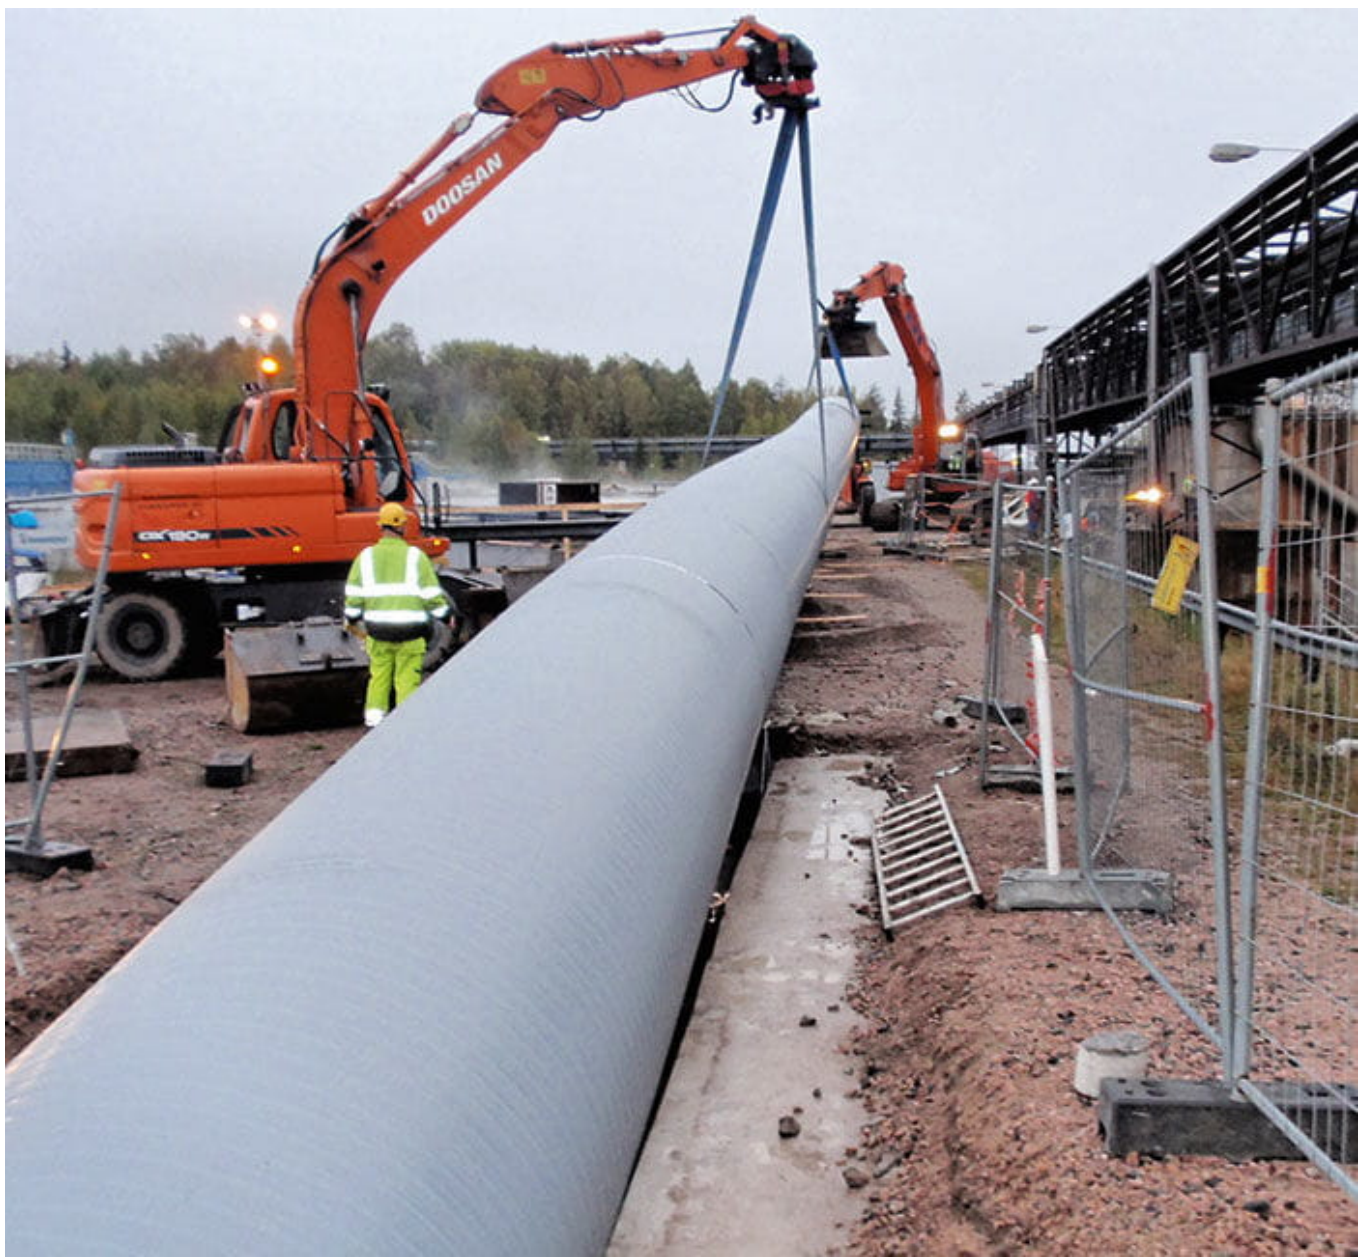
Plastic pipe withstands mill's process water

During the first stage, seventy metres of pipe, with a diameter of 1.6 metres, was installed at the mill. The pipe was slid into the existing concrete channel. Additionally, two segment bends were installed in preparation for the project's second stage. At that time, a further 120 metres of pipe will be added to the system and buried underground. As the pipeline will curve back and forth, completion of the installation work will require the addition of five or six segment bends. Dite manager Kimmo Sjöman oversaw the preparation and installation work during the first stage of the project at Imatra.

According to Mr Sjöman, sliding the stiff pipe into a square tunnel was somewhat difficult, as there was little space and the pipe did not bend easily. The outside diameter of the pipe was 1.8 metres. The pipe was slid into a square tunnel that was 2 x 2 metres in size.

"It was a tight fit, but we were successful," Mr Sjöman recounted. During the slip lining procedure, a wire was attached to one end of the pipe, which made it possible to pull the pipe into the tunnel.
