## Water treatment plant

### Aeration tank to improve the water quality

Water company Ylä-Savon Vesi Oy needed a solution to improve the water quality in water supply process. The solution was an aeration tank made of Weholite.

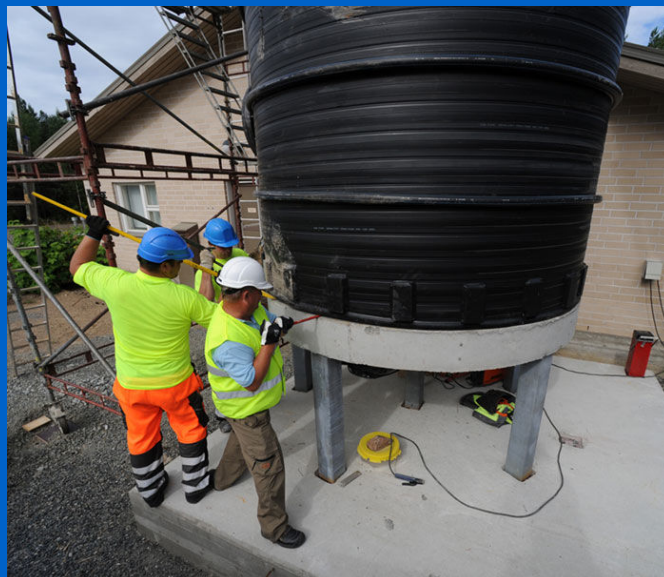
2.4 m diameter Weholite tank
