# Water treatment plant

2.4 m diameter Weholite tank

## Aeration tank to improve the water quality

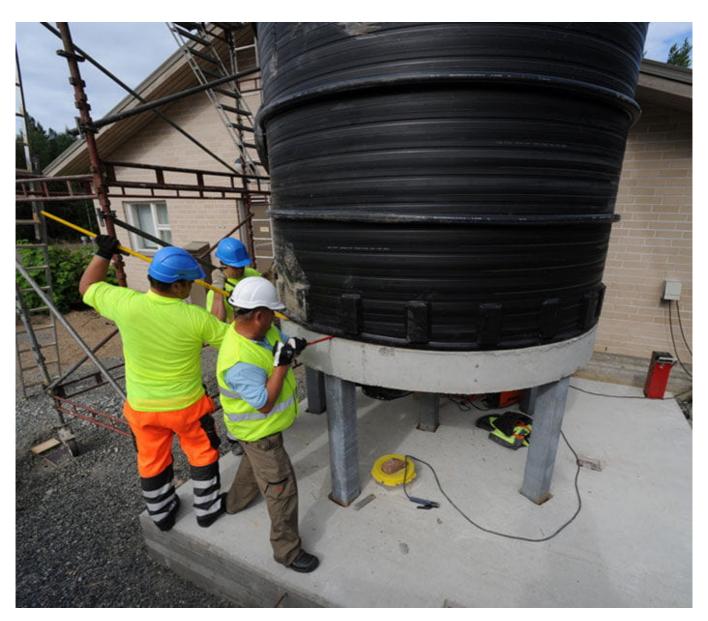
## Weholite aeration tank

In aeration that improves water quality, water is led to the tower from above. The water flows through the infill mattress in the tower, removing the carbon dioxide in the raw water. Aeration can be adjusted by blowing clean air under the tower through the mattress upstream.

The amount of air does not require the tower to withstand greater pressure than normal in normal use, but the Weholite tank can also withstand the full water pressure of the tank, for example in the event of washing or disturbances.

- The concrete slab under the tower had already been made in advance. On top of the base slab, we installed feet just over a meter high, on which we lifted a round concrete slab. The tower was attached to it, says work manager Kalevi Savolainen.

Valves and piping were installed in the space under the tower. The insulation of the lower part was also supplemented. The finished tower was raised with a truck crane. - The work went as planned. Already during the installation work, guests visited the site. The insulated aeration tank is interesting because there is little space for such massive structures in a few places, Savolainen says. The contractor completed the tower by installing exterior cladding.
