# **Quick installation in the Konotopa channel**

Weholite pipes PEHD SN4 DN2000 mm - 165 m

### Weholite guaranteed a simple and quick installation in the Konotopa channel

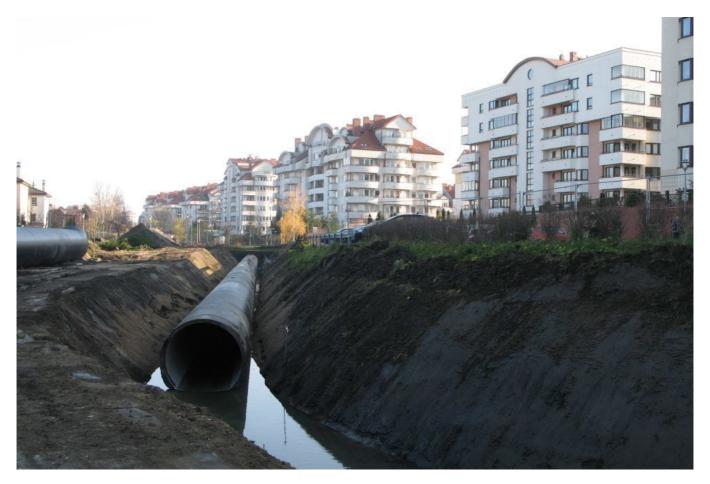
## Weholite guaranteed a simple and quick installation in the Konotopa channel

Following a tender, in September 2016 Drainage Construction Company Tolos was appointed as the general contractor for the project. Uponor Infra delivered a total of 165 metres of structured-wall PE-HD Weholite, DN/ID 2,000mm SN4 pipes to the installation site. Prep work included clearing the channel of concrete slab lining, dredging the ditch to make room for the new pipeline and laying the bedding. Uponor Infra pipe service staff then joined up the Weholite pipes to form two sections. The work was carried out on dry land on the right bank of the channel, by means of automatic extrusion welding using a WLI-3000 machine. This guaranteed the 100% tightness and homogeneity of the pipeline. A 100- metre section of pipeline was then lowered into the ditch, followed by the remaining 50-metre section with a fitted bend two days later. Since the channel was operational during installation, the two connecting sections of the pipeline were raised above the water level, where they were welded together. The pipeline was then connected to a reinforced concrete inlet of the underground section of the channel. A socket- and- spigot DN/ID200mm joint was fitted onto the pipeline, connecting it to an existing stormwater channel. Finally, the ditch was backfilled. At the spot where the new pipeline meets the open section of the channel, an outlet was secured with a steel grate to prevent unauthorised entry. The installation was completed in December 2016.
