Water treatment plant

2.4 m diameter Weholite tank

Aeration tank to improve the water quality

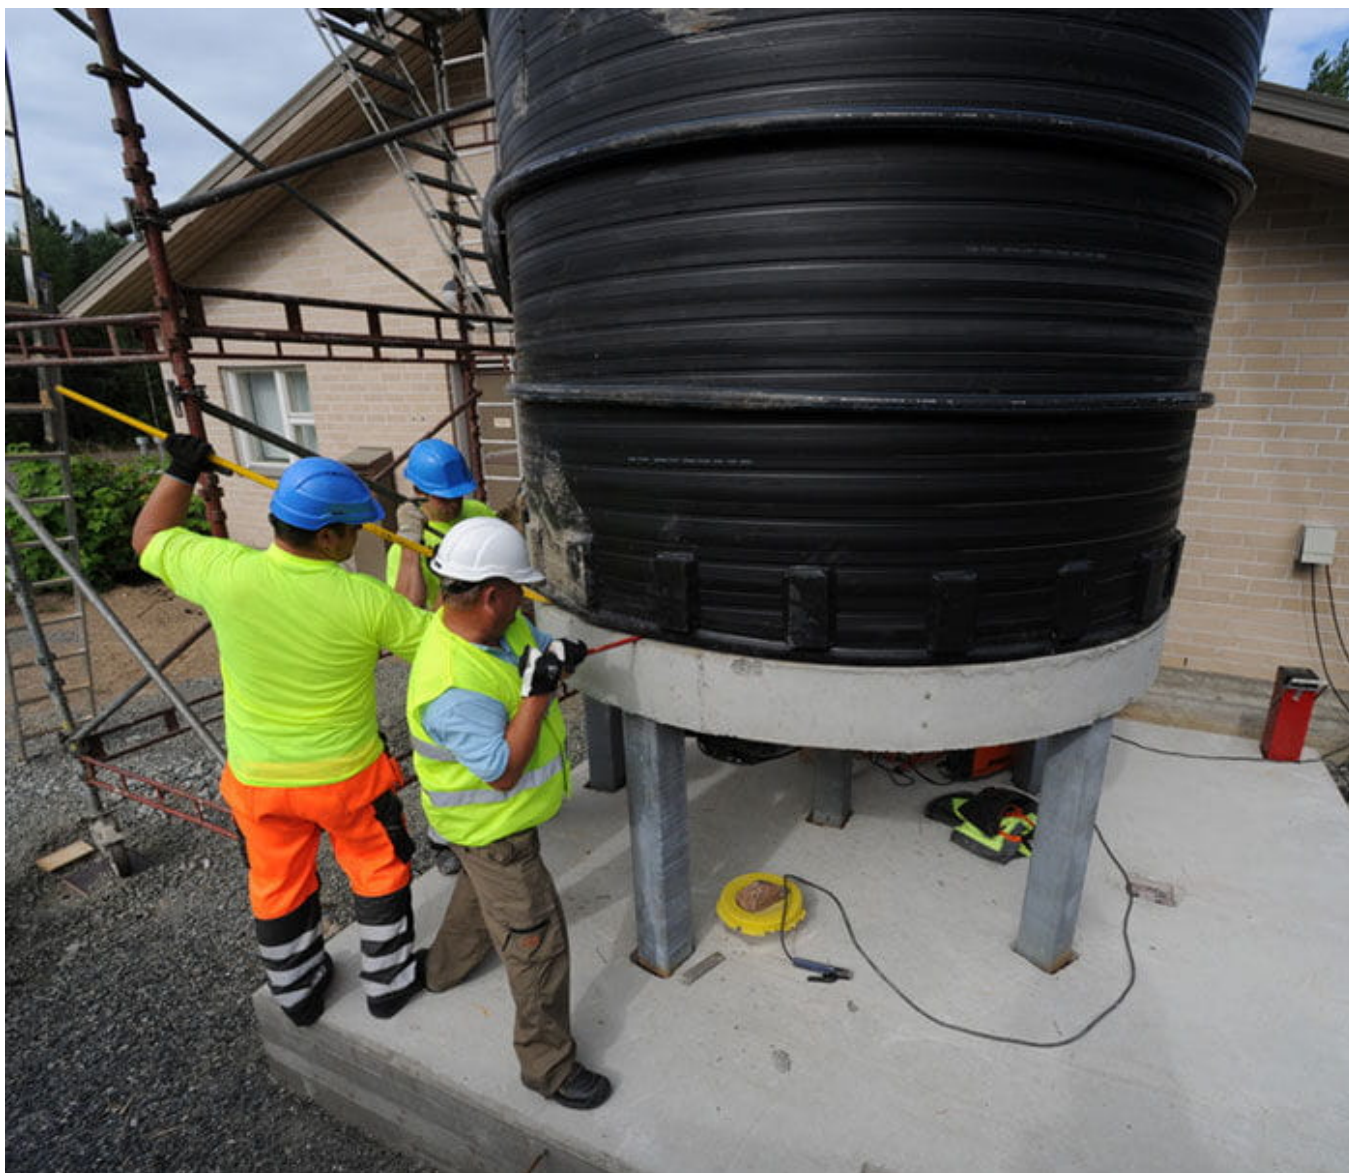
Weholite aeration tank

In aeration that improves water quality, water is led to the tower from above. The water flows through the infill mattress in the tower, removing the carbon dioxide in the raw water. Aeration can be adjusted by blowing clean air under the tower through the mattress upstream.

The amount of air does not require the tower to withstand greater pressure than normal in normal use, but the Weholite tank can also withstand the full water pressure of the tank, for example in the event of washing or disturbances.
