lisalmen Vesi renovated a trunk line by relining

Location	Achèvement des travaux
lissalmi, Finland	2017
Type de construction	Product systems
Bâtiment public	Eau potable
Type de projet	
Renovation

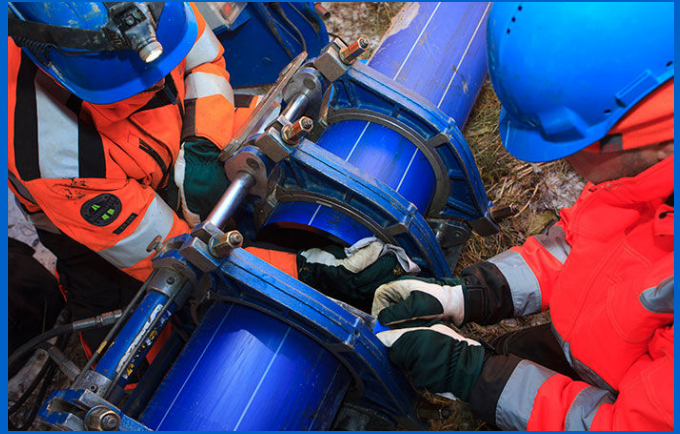
- ✓ 2.1 kilometres of 280-millimetre Profuse pipe
