Heat-only Thermostat with Touchscreen technical bulletin

Heat-only Thermostat with Touchscreen
(A3100101)

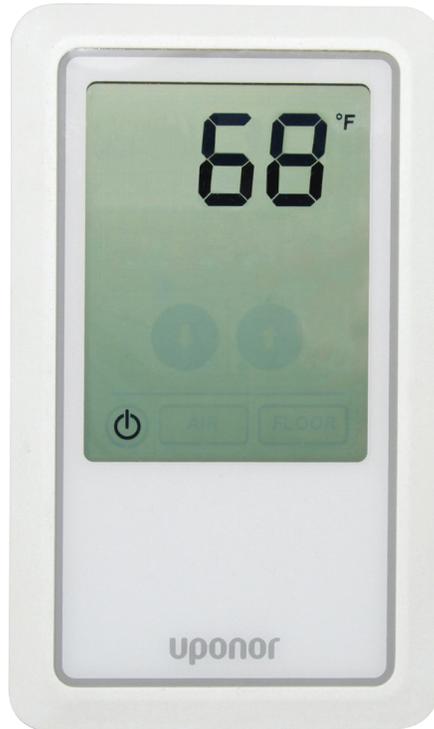
When the thermostat starts up, the display shows 9 and counts down to 1. Then, all the display icons illuminate and the countdown starts again.

An internal electronic switch used in a test mode has closed, triggering the countdown.

Return the thermostat through Uponor's Return Material Authorization (RMA) process for replacement.
