Plastic pipe withstands mill's process water

Stora Enso's Imatra mill, located in southeast Finland, annually produces one million tonnes of packaging paper and board. The Imatra mill's two production units produce raw materials for cartons, in which juice and milk are packaged. Board is also used to produce paper cups, as well as cigarette and candy packages. Board for the graphics industry is used to produce cards, covers and luxury packages.

The process water required in the manufacture of board and paper has thus far run through concrete channels to the treatment process facility, after which the water has been discharged into Lake Saimaa. The hot water that contains chemicals has worn down and eroded the concrete structures so much that a new solution had to be found for transporting the process water.

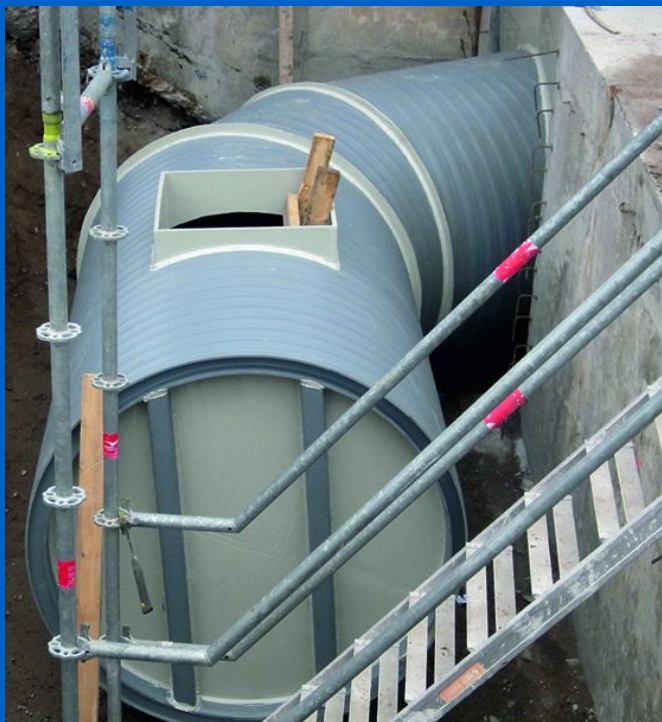
During the first stage, seventy metres of pipe, with a diameter of 1.6 metres, was installed at the mill. The pipe was slid into the existing concrete channel. Additionally, two segment bends were installed in preparation for the project's second stage. At that time, a further 120 metres of pipe will be added to the system and buried underground. As the pipeline will curve back and forth, completion of the installation work will require the addition of five or six segment bends. Dite manager Kimmo Sjöman oversaw the preparation and installation work during the first stage of the project at Imatra.

According to Mr Sjöman, sliding the stiff pipe into a square tunnel was somewhat difficult, as there was little space and the pipe did not bend easily. The outside diameter of the pipe was 1.8 metres. The pipe was slid into a square tunnel that was 2 x 2 metres in size.

"It was a tight fit, but we were successful," Mr Sjöman recounted. During the slip lining procedure, a wire was attached to one end of the pipe, which made it possible to pull the pipe into the tunnel.

Excavators then pushed the piping into the concrete channel. According to Mr Sjöman and Mr Tiilikainen, the installation was completed successfully and within the agreed timeframe. However, there were small setbacks during commissioning, when a small leak was observed in an inspection chamber. The cause of this leak was fixed by sealing up the welding seams. Everything was ready for the project's second sta
