## Quick installation in the Konotopa channel

✓ Weholite pipes PEHD SN4 DN2000 mm – 165 m

## Weholite guaranteed a simple and quick installation in the Konotopa channel

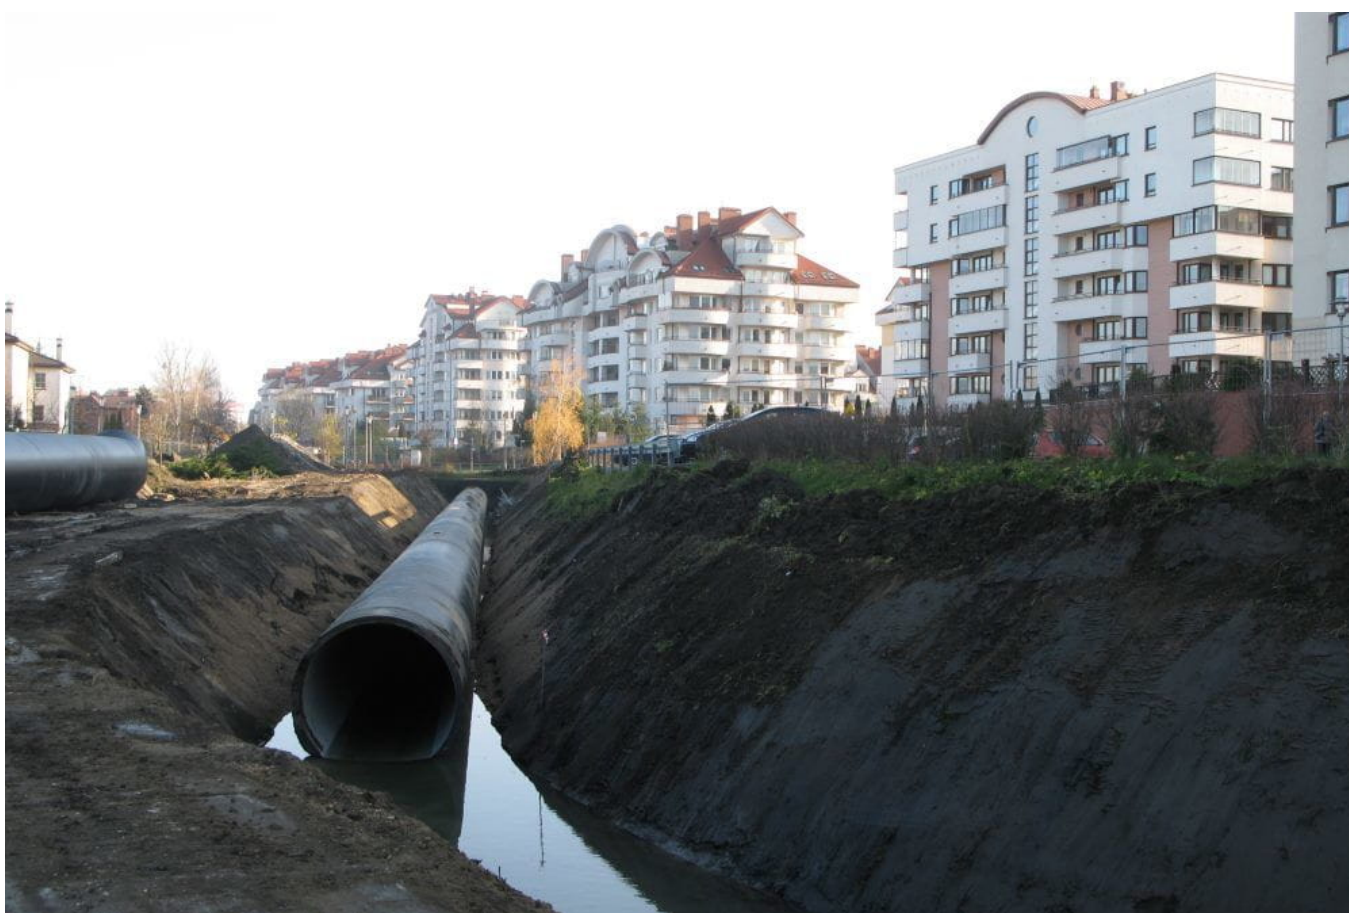
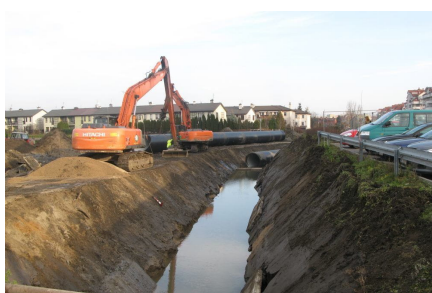
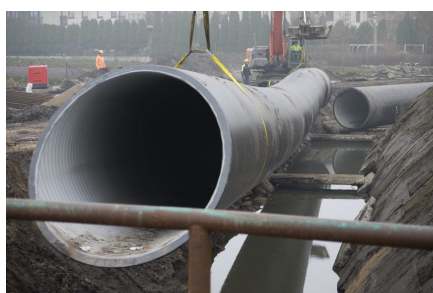
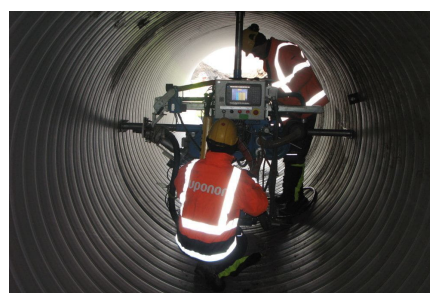
### Weholite guaranteed a simple and quick installation in the Konotopa channel

Following a tender, in September 2016 Drainage Construction Company Tolos was appointed as the general contractor for the project. Uponor Infra delivered a total of 165 metres of structured-wall PE-HD Weholite, DN/ID 2,000mm SN4 pipes to the installation site. Prep work included clearing the channel of concrete slab lining, dredging the ditch to make room for the new pipeline and laying the bedding. Uponor Infra pipe service staff then joined up the Weholite pipes to form two sections. The work was carried out on dry land on the right bank of the channel, by means of automatic extrusion welding using a WLI- 3000 machine. This guaranteed the 100% tightness and homogeneity of the pipeline. A 100- metre section of pipeline was then lowered into the ditch, followed by the remaining 50-metre section with a fitted bend two days later. Since the channel was operational during installation, the two connecting sections of the pipeline were raised above the water level, where they were welded together. The pipeline was then connected to a reinforced concrete inlet of the underground section of the channel. A socket- and- spigot DN/ID200mm joint was fitted onto the pipeline, connecting it to an existing stormwater channel. Finally, the ditch was backfilled. At the spot where the new pipeline meets the open section of the channel, an outlet was secured with a steel grate to prevent unauthorised entry. The installation was completed in December 2016.
