Quick installation in the Konotopa channel

Weholite pipes PEHD SN4 DN2000 mm – 165 m

Weholite guaranteed a simple and quick installation in the Konotopa channel

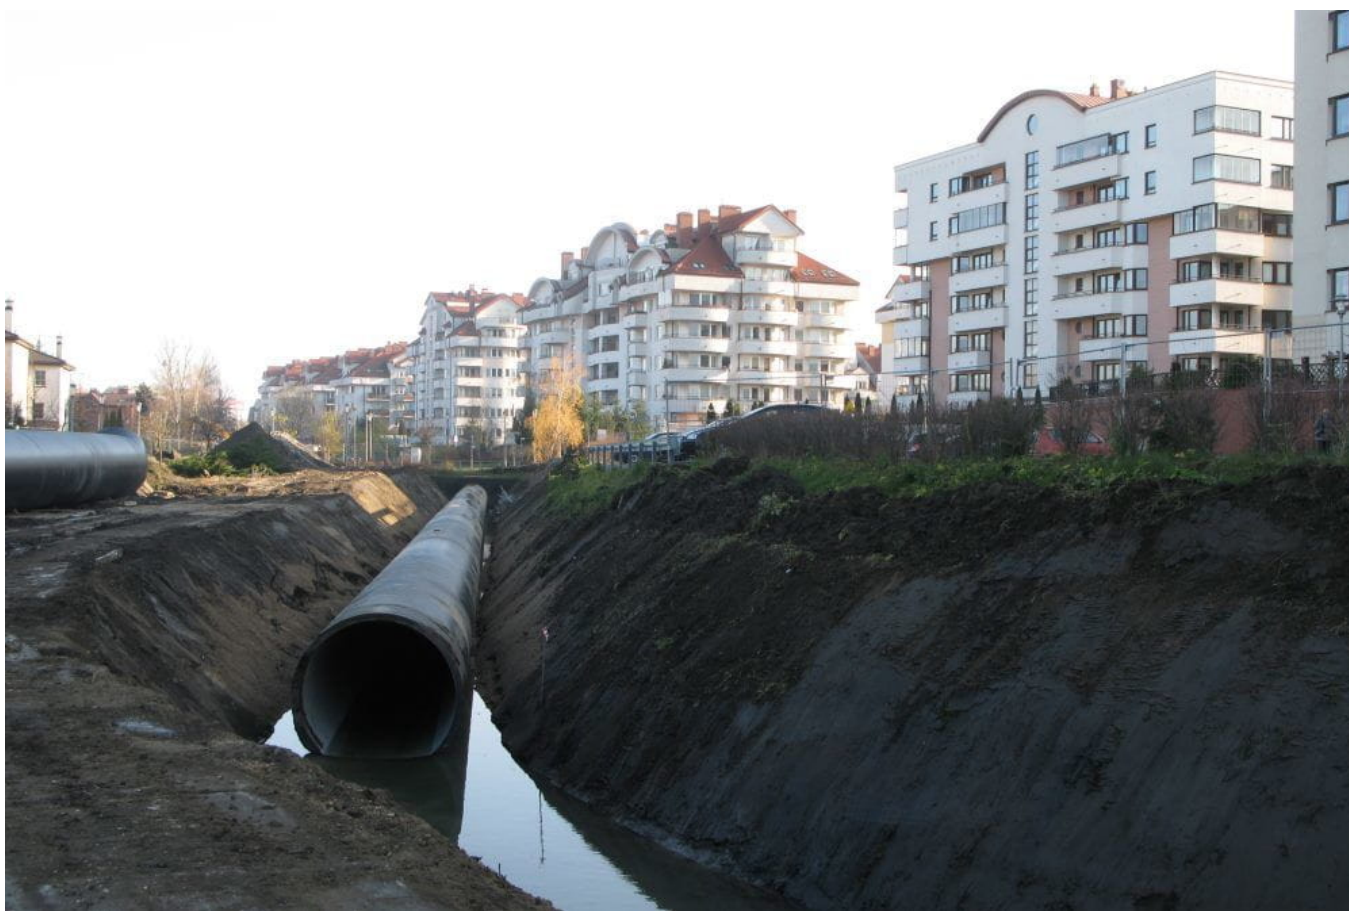
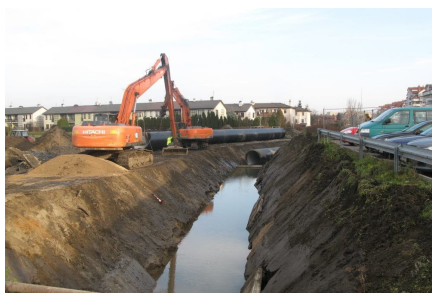
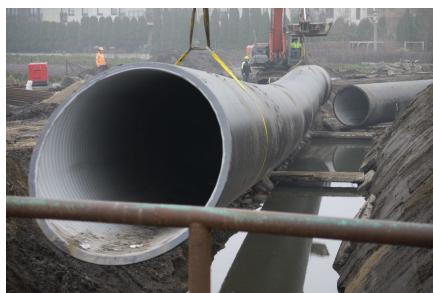
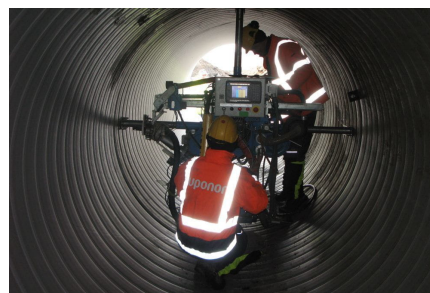
Weholite guaranteed a simple and quick installation in the Konotopa channel

Following a tender, in September 2016 Drainage Construction Company Tolos was appointed as the general contractor for the project. Uponor Infra delivered a total of 165 metres of structured-wall PE-HD Weholite, DN/ID 2,000mm SN4 pipes to the installation site. Prep work included clearing the channel of concrete slab lining, dredging the ditch to make room for the new pipeline and laying the bedding. Uponor Infra pipe service staff then joined up the Weholite pipes to form two sections. The work was carried out on dry land on the right bank of the channel, by means of automatic extrusion welding using a WLI-3000 machine. This guaranteed the 100% tightness and homogeneity of the pipeline. A 100- metre section of pipeline was then lowered into the ditch, followed by the remaining 50-metre section with a fitted bend two days later. Since the channel was operational during installation, the two connecting sections of the pipeline were raised above the water level, where they were welded together. The pipeline was then connected to a reinforced concrete inlet of the underground section of the channel. A socket- and- spigot DN/ID200mm joint was fitted onto the pipeline, connecting it to an existing stormwater channel. Finally, the ditch was backfilled. At the spot where the new pipeline meets the open section of the channel, an outlet was secured with a steel grate to prevent unauthorised entry. The installation was completed in December 2016.
