Maksimir stadium, Zagreb

After the renovation, the field at Maksimir stadium in Zagreb, Croatia is now equipped with Uponor Meltaway, a snow and ice melting system.

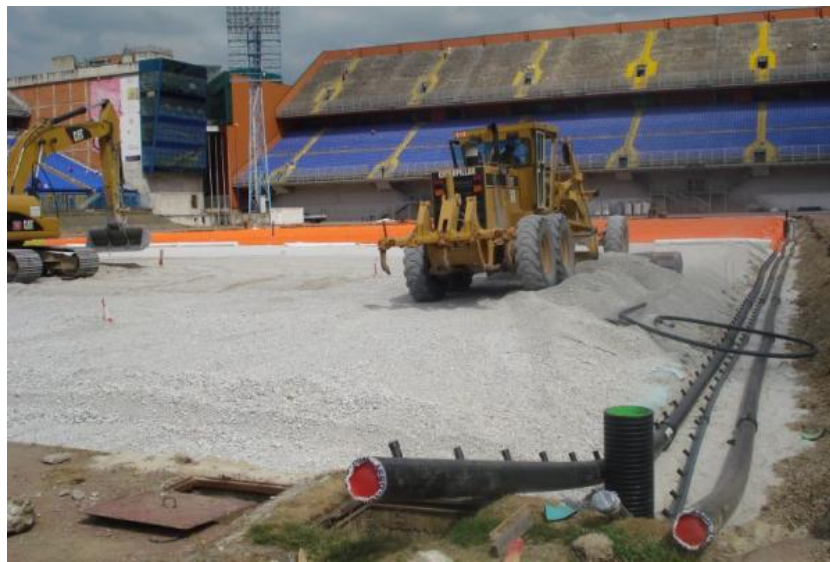
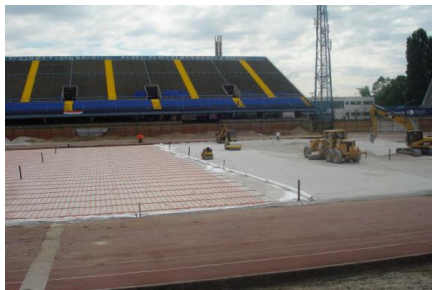
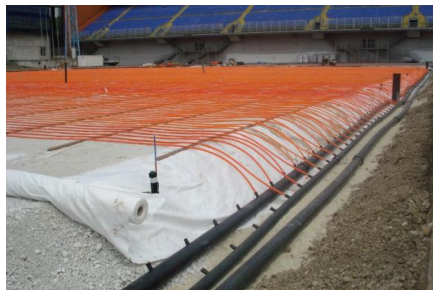
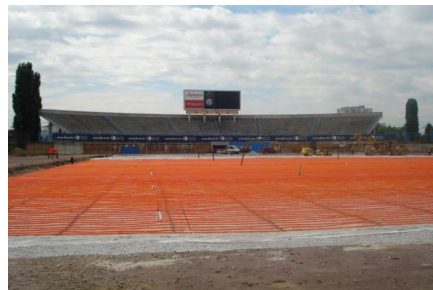
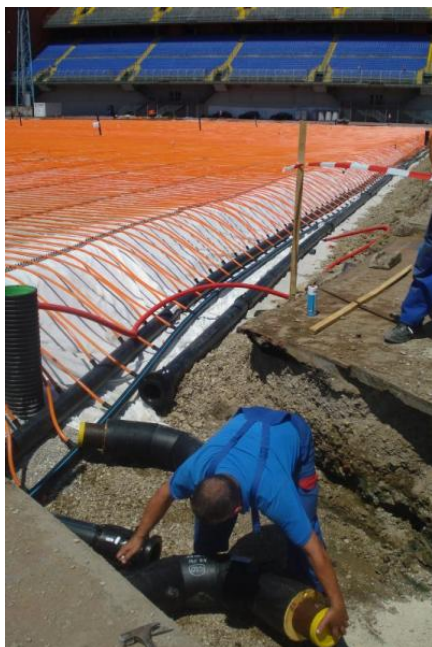
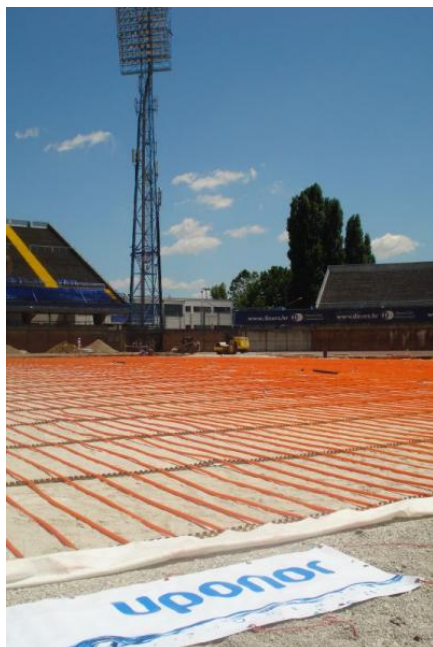
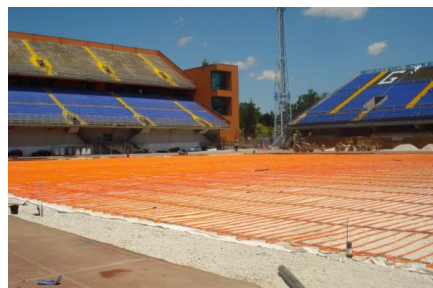
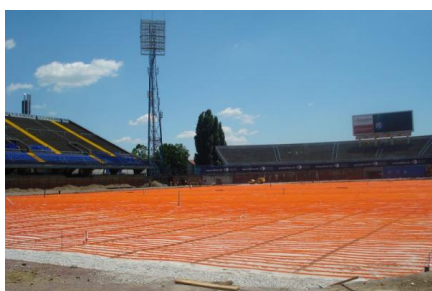
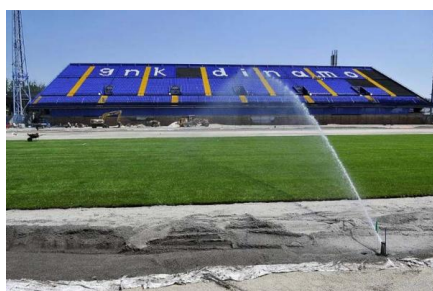
Maksimir stadium, Zagreb

Uponor Meltaway system has been installed under the natural grass playing field. Its main elements are cross-linked polyethylene silane XLPE pipes that are softer and more flexible because they were specially designed for defrosting of exterior surfaces. Approximately 24 km of 25 x 2.3mm pipes have been used during installation, as well as Uponor fittings, reductions, connections, fixations, automatic units etc. Loops of equal length are connected through the Tichelmann manifold from PEHD pipes to an existing, although appropriately modified, boiler room. Pipes are covered with a layer of quartz sand, followed by soil and finally by rolls of grass.
