Water treatment plant

- 2.4 m diameter Weholite tank

Aeration tank to improve the water quality

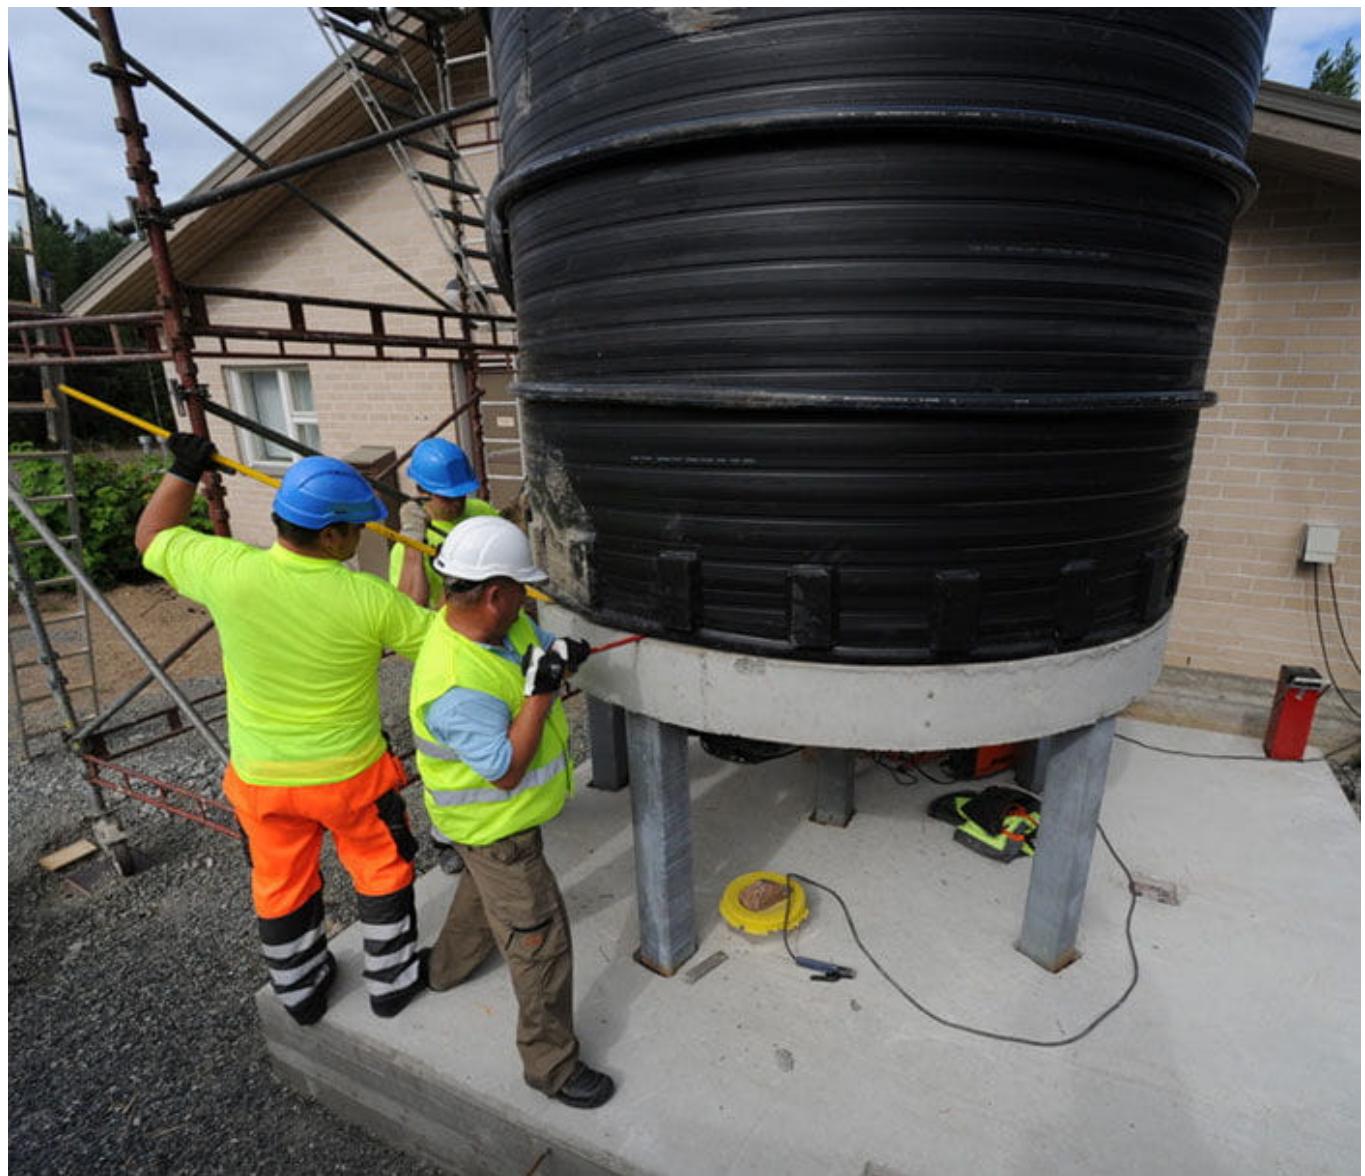
Weholite aeration tank

In aeration that improves water quality, water is led to the tower from above. The water flows through the infill mattress in the tower, removing the carbon dioxide in the raw water. Aeration can be adjusted by blowing clean air under the tower through the mattress upstream.

- The concrete slab under the tower had already been made in advance. On top of the base slab, we installed feet just over a meter high, on which we lifted a round concrete slab. The tower was attached to it, says work manager Kalevi Savolainen.

Valves and piping were installed in the space under the tower. The insulation of the lower part was also supplemented. The finished tower was raised with a truck crane. - The work went as planned. Already during the installation work, guests visited the site. The insulated aeration tank is interesting because there is little space for such massive structures in a few places, Savolainen says. The contractor completed the tower by installing exterior cladding.
